Experimental Study on Destroy of Dolos Armored Breakwater, Pacitan in Indonesia

Abstract—the breakwater armored with 15 T Dolos block had destroyed several times during constructing even the section verified by experiment study in wave flume, and it was destroyed again after the repair design and test verification. The damage phenomena were compared between on site and in the lab. In the third model test study, it proposed the problems of rod broken caused by block shaking and rolling impact, as well as overall sliding caused by small block supporting the big block. The stability of the repair plan was verified again by increasing the block weight, and the section was verified under the wave impact after on-site implementation. The study also revealed the fact that shaking led to the broken of the rod and the breakwater failure.

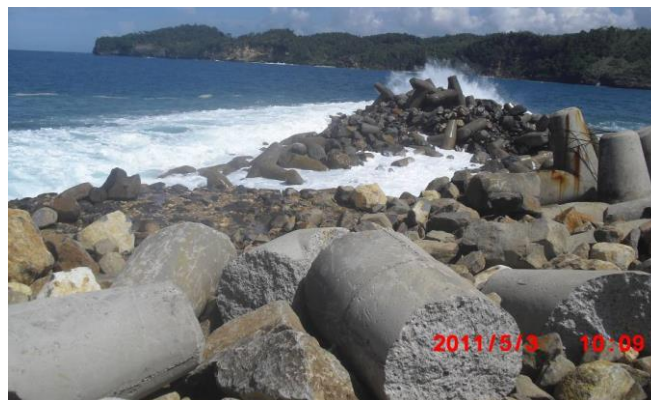
m. At the same time, the long period environment makes the water dumping and filling machine usually used for the construction of the breakwater unsuitable for this project, large construction ships and machines are unable to carry out the dumping and filling construction on the water, and can only be pushed on the road. Due to the lack of accurate sea wave forecast due to local conditions, the head of the embankment is washed out more than 10 times under the construction state, and the riprap core stone formed in the daytime may be washed out the next day, and the Dolos block may have a broken rod (see Figure 3), so the construction of the designed breakwater cannot be

Figure 3. Rod Fracture of armour block on site

recommended that the status of the armor block be regularly inspected and maintained or modified into a sturdy manual armor block with support rods.

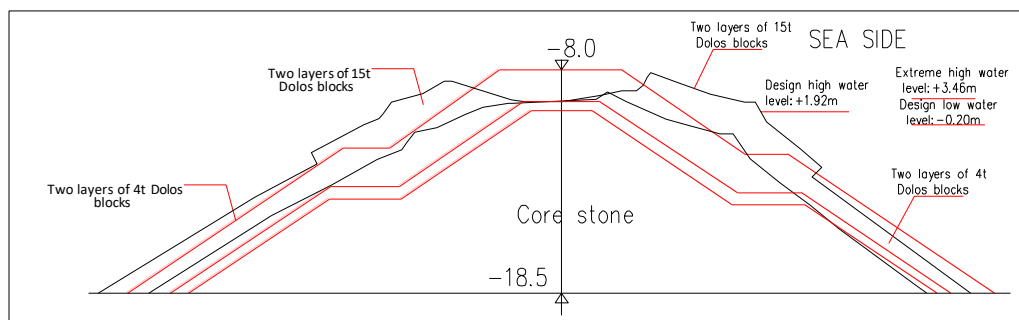
successfully completed, The actual section formed on site is shown in Figure 4 below, that is, the elevation of the embankment top is about +5.70 m, two layers of 4t Dolos blocks are placed below the sea side elevation of - 4.0 m, and two layers of 15t Dolos blocks are placed at the corner of the embankment top above the sea side elevation of - 4.0 m. Due to the sea conditions in the project area, no cushion block stone is laid under the armour block, and the armour block is directly placed on the 10~1000 kg embankment core stone. The port side of the section and the sea-side block armour are basically symmetrically placed.

Figure 4. Breakwater section at project site

(The red line is the original design section, and the black line is the current section)

On the model, the stability of breakwater section at project site (shown in Figure 4) is directly verified by using wave elements (3.5m wave height) during the construction period. The test shows that under the wave action of the design high water level, due to the lack of hook up of the embankment top block, the instability will soon occur under the wave action, as shown in Figure 5 (b).

section is improved, that is, a layer of 4t Dolos blocks is added to the foundation of two layers of 4t Dolos blocks below the sea side elevation of -4.0m (that is, three layers of 4t Dolos blocks are used to protect the surface), and 200~400kg riprap prism (15.4m long and 5.0m thick) is added at the foot of the slope. The other structures are the same as the original design; At the same time, 15 t Dolos blocks are placed on the top of the breakwater.

The test results show that after the failure, riprap should be added to the sea-side as soon as possible to form bottom protection and riprap prism to support the

surface protection block. When the top of the breakwater is not protected, the upper part is seriously damaged under the action of strong waves. It is necessary to speed up the placement of 15 t Dolos blocks on the top of the breakwater according to the project progress to prevent the 15 t Dolos blocks on both sides from being washed away by waves after the core stones on the top of the breakwater are brushed.

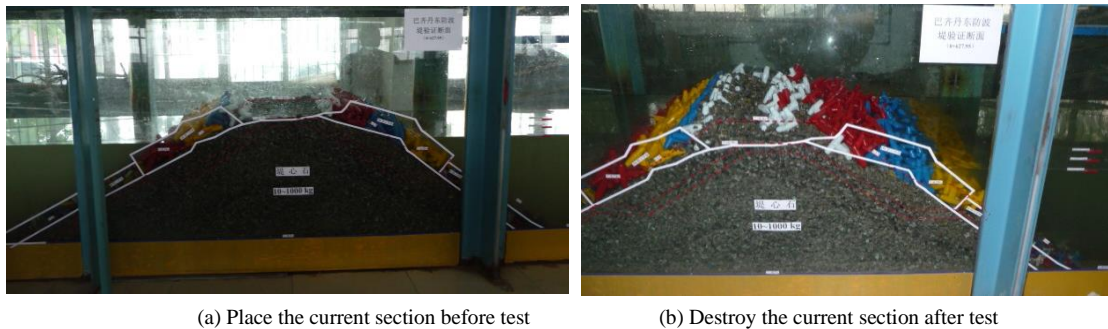
Figure 5. Mold test Results for breakwater section at project site

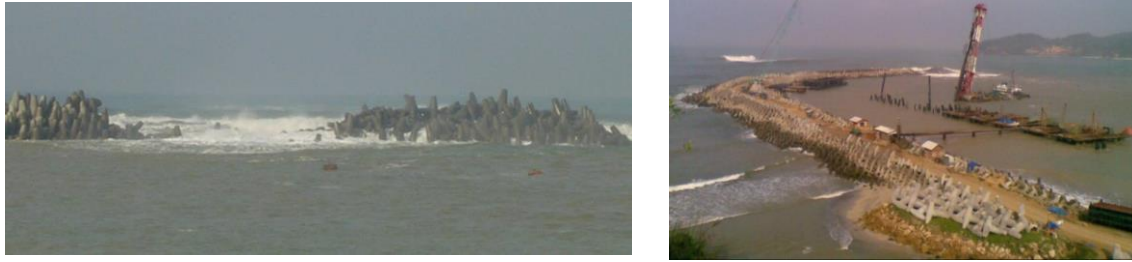
However, due to the large waves during the construction, the installation can only be carried out on the road. In order to ensure the construction completed, if the top of the breakwater cannot be protected in time, the breakwater will be damaged again (see Figure 6). The final failure section is shown in Figure 7. The whole breakwater forms a large gentle slope.

Figure 6. Site damage of section after the second repair

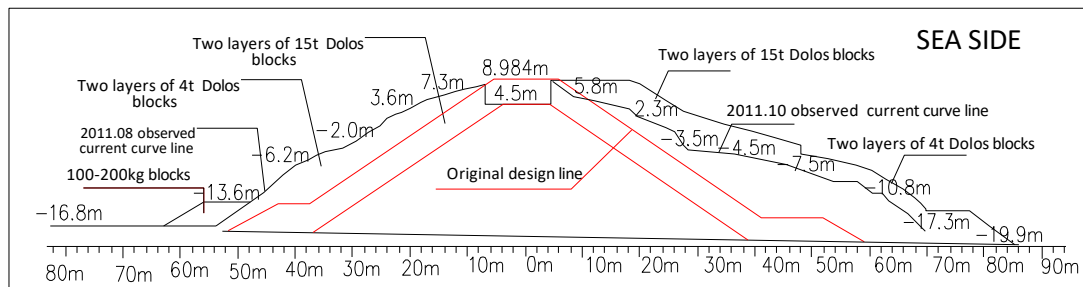
Figure 7. Shape of the second damaged breakwater section at project site

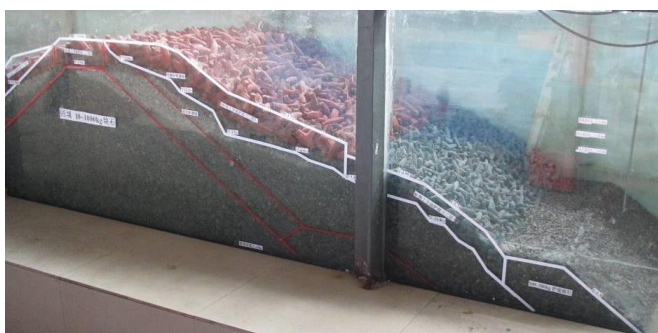
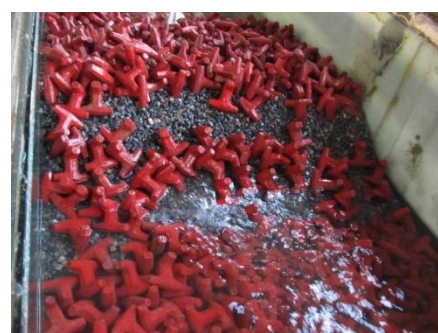
The second destruction process of the breakwater was verified again in the wave flume. It is known from the test that due to the gentle slope and poor connectivity of the armor block, the breakwater was unstable under the impact of strong waves, as shown in Figure 8.

Figure. 8. Model test results for the second damaged breakwater section , instability

For the section form of breakwater failure on site, the section is modified and improved according to the instability situation and previous research results^[10]. The mixed prism combination of block stone and Dolos block is adopted. The results show that the section instability rate and block shaking are improved. The main reason is that the block stone has a good squeezing and embedding effect on the block after all or most of the blocks are embedded in the prism block stone, limiting its displacement, thus ensuring the stability of the whole slope. However,

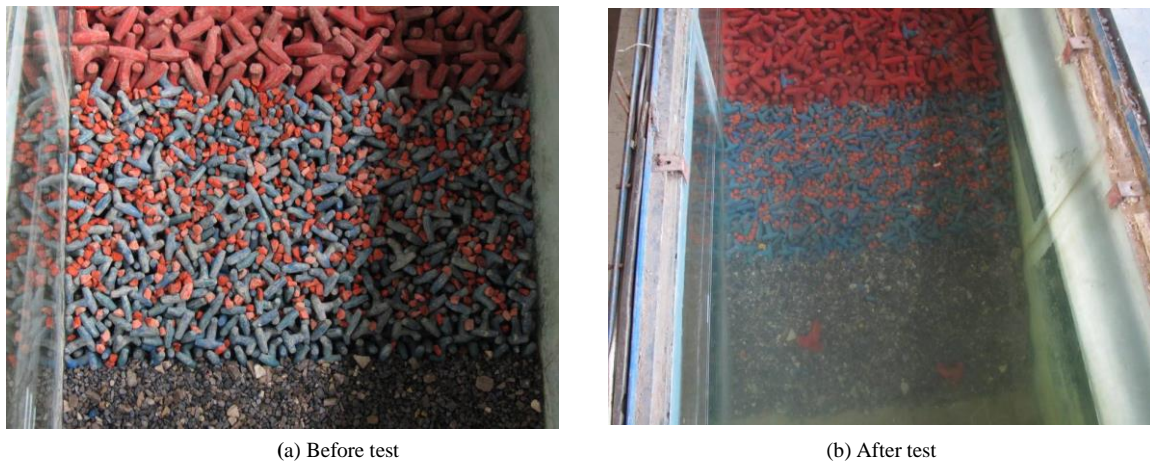
Figure. 9. Test Results of Final Perfection Section

during the test, it was found that under the action of strong waves, the block stones rolled up and down on the surface of the armor block along with the waves. Therefore, the specifications should be strictly controlled during the construction to prevent damage to the protruding block bars due to the overweight of the block stones, and the block stones could not fall into the gaps between the blocks, thus weakening the function of the mixed prism. In addition, the mixed prism of block stone and Dolos block is: 200~600 kg block stone and 4 t Dolos block are combined, and the amount of block stone thrown within 22 m of 4 t Dolos block armour is distributed differently, that is, 9 m³/100 m² block stone is thrown randomly from the junction of 15 t and 4 t Dolos block to 7 m, 6.3 m³/100 m² block stone is thrown randomly at 55 m~62 m (see the abscissa of Figure 7, the same below), 2.7 m³/100 m² block stone is thrown randomly at 62 m~70 m, and the test results are shown in Figure 9.
