# Flooding Causes Analysis in The Engine Room of KM. Nusantara Akbar

**Abstract**—this study analyzes about the cause of flooding in KM Nusantara Akbar's engine room. However, this study mainly focuses on flooding that caused by shaft deflection. It was found that the cause of the flooding was packing, driven by a deflection shaft. Analysis was done by a review of the technical and non-technical factors. The analyze of engine room flooding is carried out by using 5 whys method to asses the root causes. The results show that the causes of flooding are reconditioned flange bolts that have been damaged and the addition of flax on the bearing shaft has to cope without straightening axle deflection itself, equipment to overcome the failure system is very less, the workplace is dirty and uncomfortable and happened miss communication between the crews.

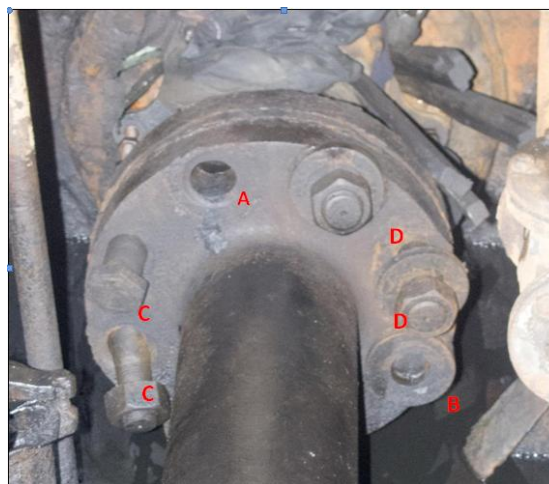
Figure 3. Flange Condition After The Accidents

1. 1 piece coupling bolts are not in place (A).
2. 1 piece of broken coupling bolts (B)
3. 2 pieces almost detached, the possibility is breaking up the middle
4. 2 bolts still attached but there is an additional ring, it should not be.
5. 2 pieces bolts that are at the bottom is not visible in this image.
6. Seeing fastening bolt on the clutch shaft, it is likely not a fitted bolt.
7. When the intermediate shaft is rotating, intermediate shaft bearings going to sway. To reduce the sway then mounted a tackle block as in Figure 4 (in this picture chain fastened to the foundation bearing tackle)

1. The broken flange bolt was not replaced but reconditioned. (Welded)
2. There is no special treatment when carried out repairs on the propeller.

2. From the KNKT's data, some flange bolts were broken and loose, from the FEM modeling obtained bolt broken because the working force was beyond the normal load.

3. Welding of flange bolts that have been broken shall not be carried out because it will change the character of the material that has received heat and the addition of different materials.
4. The addition of flax in the bearing to adjust the deflection shaft should not be carried because the point of deflection will creep at another point.

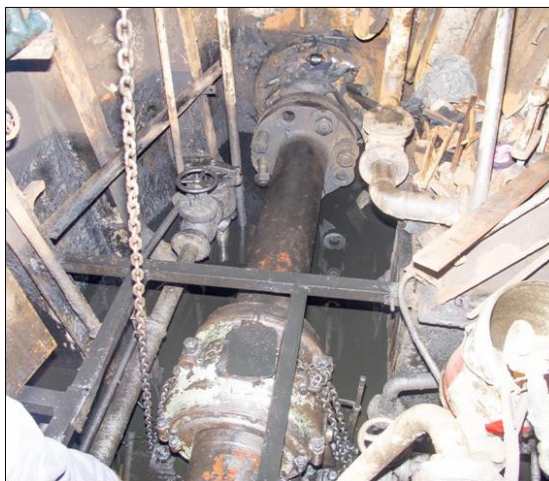
Figure. 4. Bearing Condition

3. The shaft alignment was not conducted but improved by setting flax to shrink deflection.

1.2.1.1.1.2. Because the addition of flax was on the bearings to handle deflection shaft.

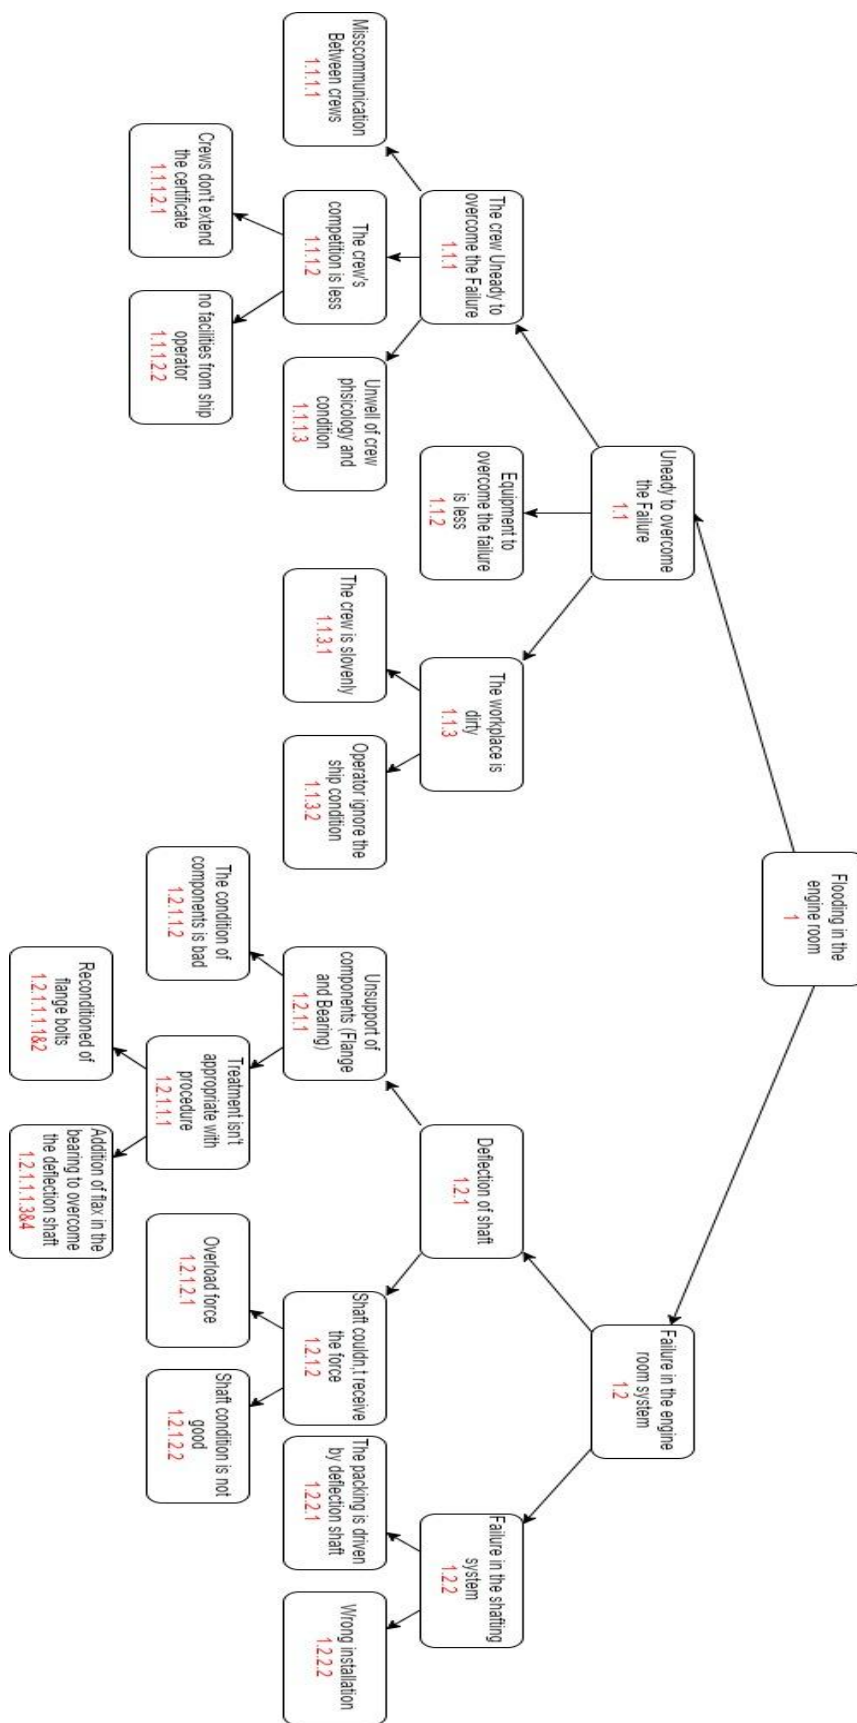
Figure. 5. Why Tree of flooding in the engine room of KM. Nusantara Akbar case

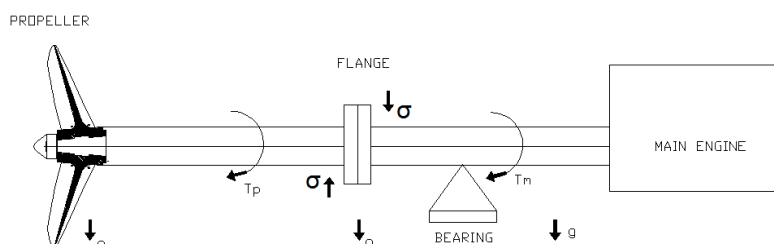
Figure. 6. Free Body Diagram

O: shear force from the main engine and propeller torque to the flange bolts

O : 1,951 Mpa

$$= 2.230 \text{ MPa}$$
