Overflow Analysis on the FO Purifier of KM Tanto Sukses Vessel

Bagas Sadewo¹, Agus Prawoto², Trisnowati Rahayu³, Azis Nugroho⁴, Nasri, M.T⁵ Rama Syahputra⁶, Imam Sutrisno⁷

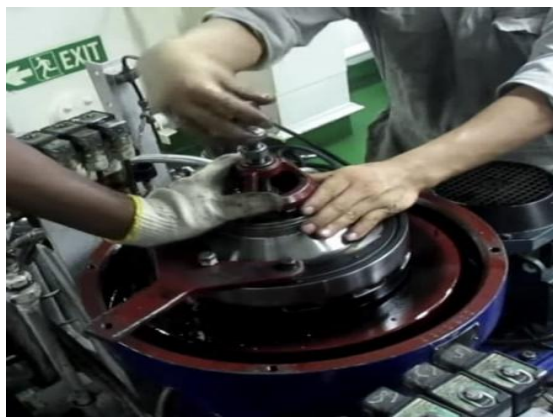
Figure 1. Bowl Lifting Process

The initial step in this observation process involved lifting the bowl hood, which serves as a protective cover for the main internal components. This hood functions to shield the internal parts from dust and physical damage. Once the bowl hood was removed, the next step was to detach the lock ring, a locking mechanism that secures various components in place. This ring is typically tightly fitted and must be removed carefully to avoid damaging adjacent parts. The process continued with the removal of the camber cover and the inlet pipe. The camber cover protects the angular section of the system, while the inlet pipe channels air or fuel into the system. These components are often tightly connected, requiring special care to prevent damage to joints or piping during disassembly.

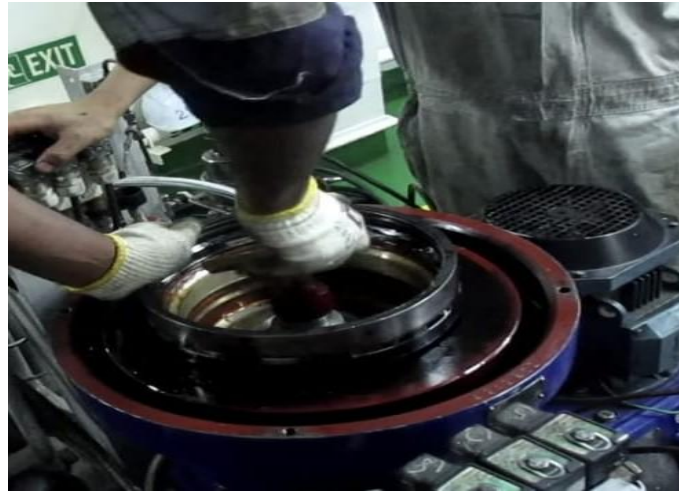
Figure 2. Sliding Bowl Removal

disc functions to regulate this flow, and the final distributor ensures accurate distribution to other system sections[23]. Once these components were removed, access to the internal system was significantly improved. The process was followed by removing the sliding bowl, a movable part that regulates dynamic material flow within the system.

With the sliding bowl detached, further inspection was conducted on the low-pressure water system's O-ring. Observation revealed that the O-ring had become stiff and lost flexibility, compromising its sealing function. This stiffness can potentially cause leakage and reduce the overall system performance.

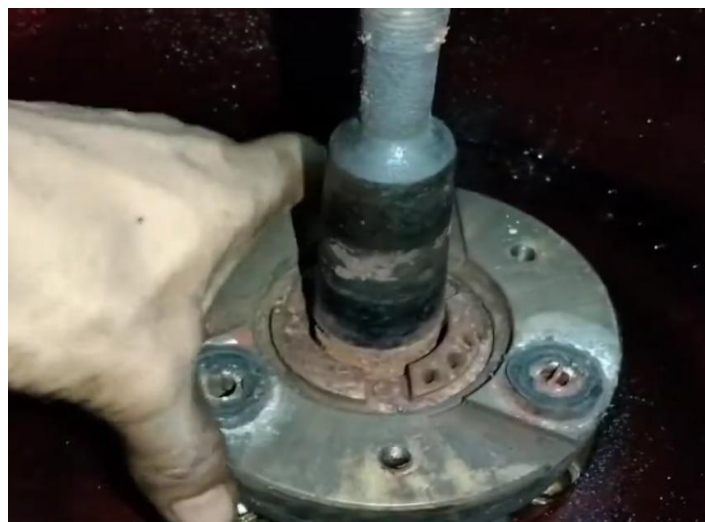
Figure 3. Photo of O-ring

Further examination identified the O-ring damage as being caused by a combination of factors, primarily material degradation over time and suboptimal material quality. As the O-ring aged, its elasticity and flexibility diminished, making it incapable of adapting to pressure and shape changes within the system. Based on these findings, it is strongly recommended to replace the damaged O-

ring with a new one that meets the appropriate specifications and quality standards required for the low-pressure water system. Regular inspections should also be implemented to monitor O-ring condition and prevent similar failures in the future. This proactive approach will help maintain system performance and reduce the risk of operational disruptions[24].
