LESSONS LEARNED FROM THE 2010 CANTERBURY EARTHQUAKE AND AFTERSHOCKS, NEW ZEALAND

by S. Wijanto^a, C.W.K. Hyland^b and T. Andriono^c

ABSTRACT

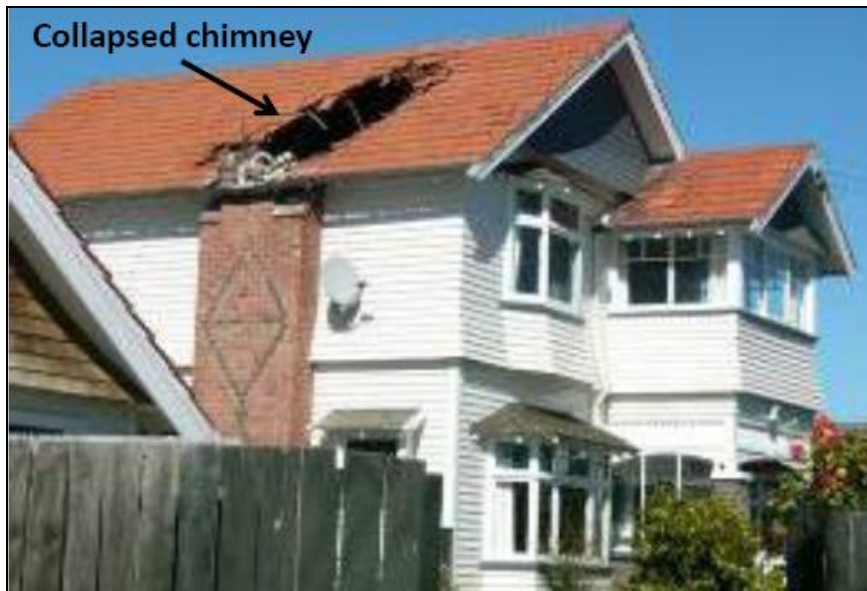
Most houses in the vicinity are built using light timber framing, others use steel framing, solid wood, brick and masonry houses. During the 4 September 2010 earthquake, thousands of chimneys were claimed to have collapsed and resulted in damage of the surrounding roof structure (see Fig. 5), neighbouring properties and vehicles. Housing damage was typically limited to damage from liquefaction and related lateral spreading or settlement of foundations. Houses built in the last twenty years that are founded on unreinforced concrete slab on

Fig. 5. Collapsed chimney of residential housing

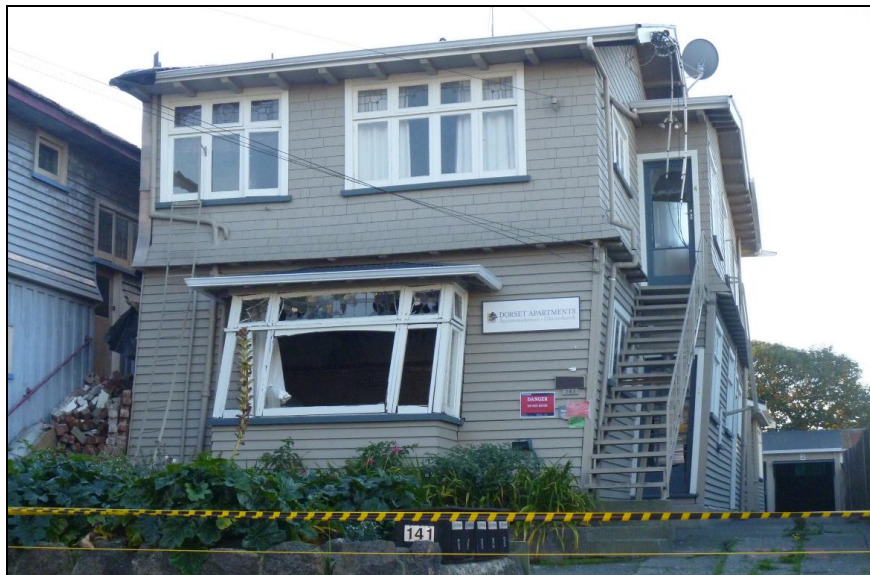
Fig. 6. Soft storey failure of timber housing

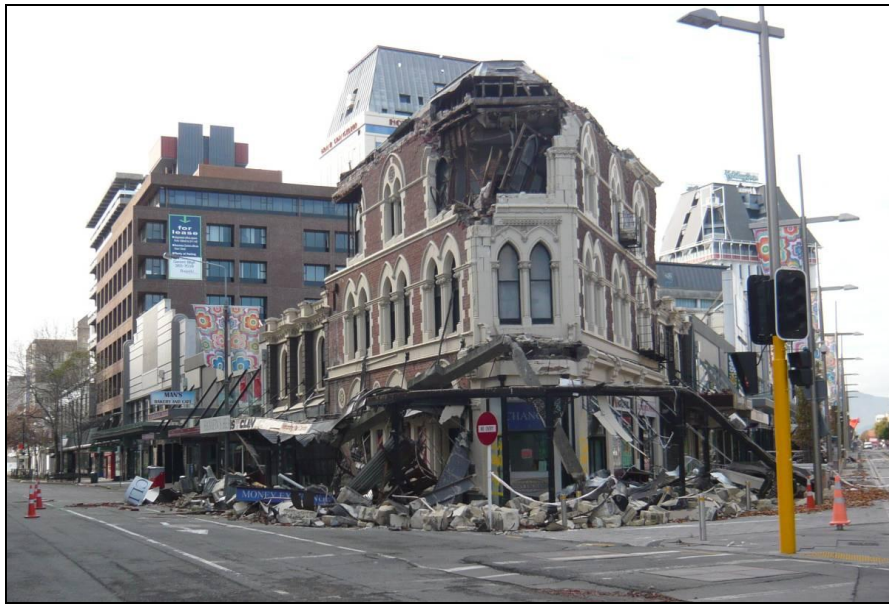
However, after the aftershock 22 February 2011, many URM structures, particularly in the Christchurch business districts, suffered more damage, and partial collapse due to their close proximity to the shaking (see **Fig. 7**). There was also considerable damage to other URM buildings which are historic or heritage structures. The Christchurch City Council and building owners will have to set priorities on which buildings must be saved and which may need to be demolished.

Fig. 7. Three storey URM building in the CBD severely damaged

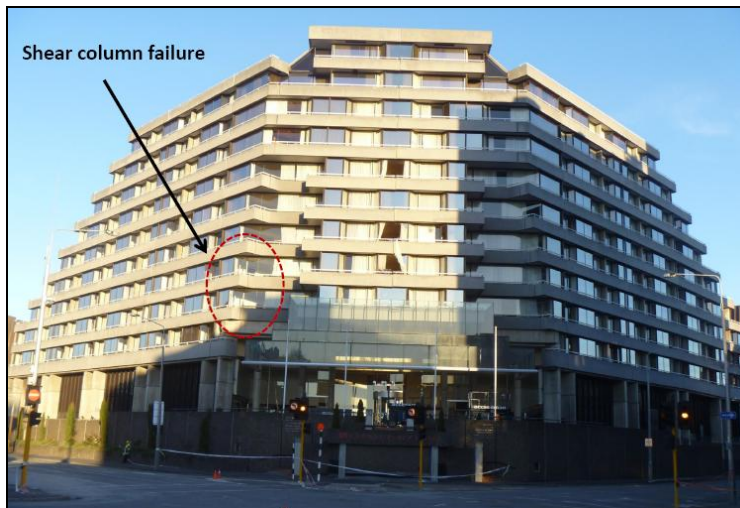
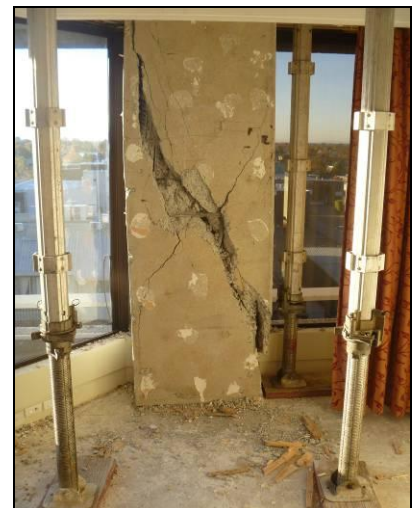
Fig. 8. Shear failure column at post-1970 RC building
