Failure Analysis of Bend Tube Preheater on Heat Recovery Steam Generator

R. Sony Endardo Putro¹, Arif Hariyadi² and Suwarno^{1,*}

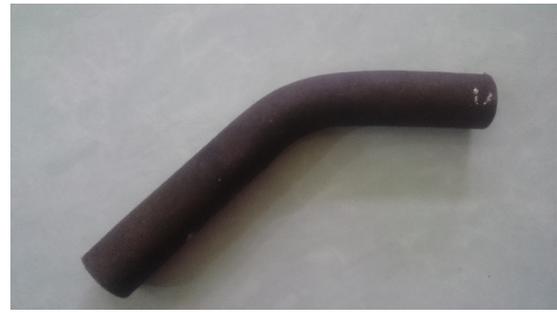
Visual inspection carried out on inner and outer surface of bend tube preheater was to find damage such as holes and cracks, forming of corrosion product, and color changes that occurs on the surface [1]. Visual inspection on inner surface of bend tube preheater showed that the entire surface covered with thin red-brick layer and distributed evenly along the surface pipe (Figure 4). It shows that corrosion processes associated with water as corrosive media occurred. There are not any visible damage such as cracks on the inner surface of bend tube preheater. So we concluded that the corrosion process occurred on the inner surface belong to the type of uniform corrosion[2]. On outer surface of bend tube preheater, there is a brownish-black layer that covered along surface pipe with even distributed (Figure 3). It shows that corrosion processes occurred on outer surface of bend tube preheater. There are not any visible damage such as cracks on the outer surface of bend tube preheater.

Figure 3. Outer surface condition of bend tube preheater

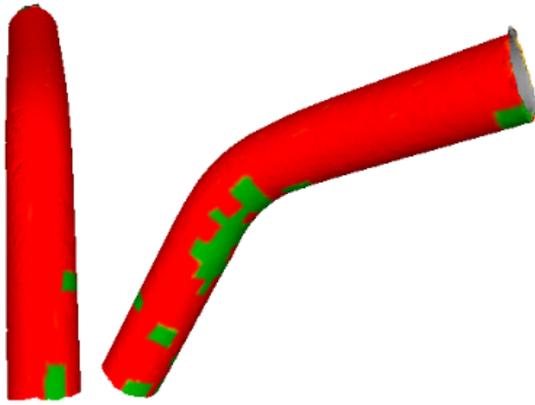
After measurement on each sample, the result of measurement is combined with 3D file of specimens from 3D scanning. Then, a codification was given to the combined 3D file to show the local thickness of pipes. The red color in 3D image shows if the location thickness is below the critical thickness (< 1.778 m), while the green color in 3D image shows the location thickness is still above the

critical thickness (1.778 m). The combined 3D images results can be seen on Figure 5.

Figure 5. Combined 3D image for specimen 1B

The result of visual inspection and measurement on inner and outer surface of each specimens showed that bend tube preheater is in critical condition and should be replaced, although there are not any signs of damaged such as leaking or crack on four specimens. However, corrosion process happens on every specimen based on color changes, reduction in thickness, and forming of oxide layer on specimen surface. Combined 3D image for other specimens can be seen on additional information chapter.

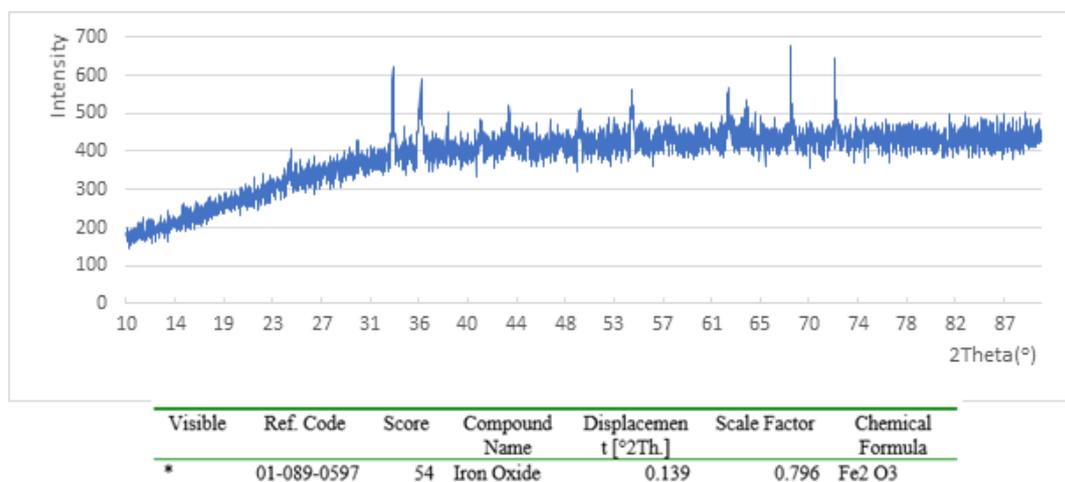
XRD test result on inner surface of bend tube preheater (Figure 6) showed, that red-brick layer is detected as hematite or Fe_2O_3 . Hematite formed by direct contact between metal surface with water continuously. Hematite in inner surface of sample test formed with a thickness below 1 mm. Corrosion process occurs continuously due to the direct contact between metal surface and water, so that reduction of thickness also occurs continuously. From Figure 6 we also conclude that the inner surface of bend tube preheater undefiled from contaminants or abrasive particles, so the corrosion occurs in inner surface is pure due to direct contact between metal surface and water.

Figure 6. XRD test result on inner surface of bend tube preheater

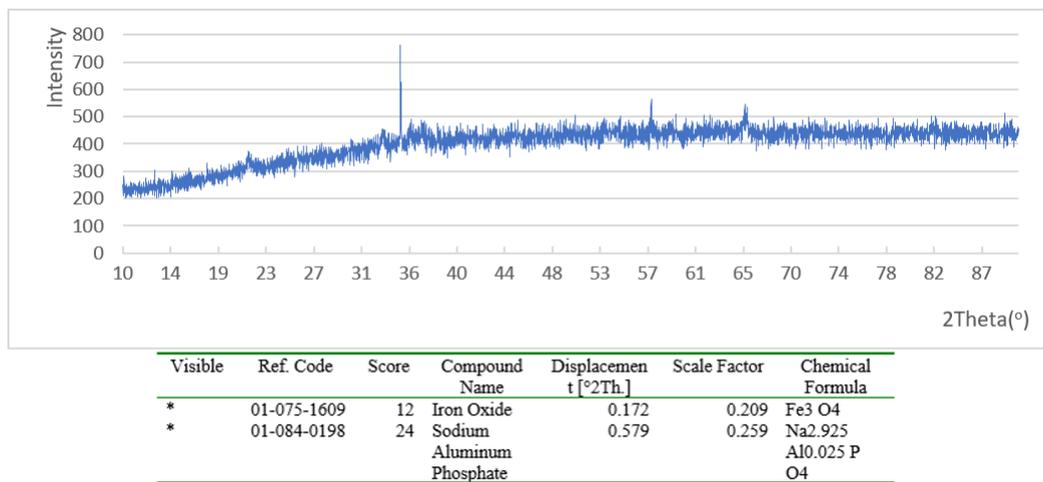
XRD test result on outer surface of bend tube preheater (Figure 7) showed, that brownish-black layer is detected as magnetite or Fe_3O_4 and sodium aluminum phosphate. Corrosion process that occurs on outer surface is different from inner surface due to the difference between corrosive media. A direct contact between metal surface and hot gasses from gas turbine combustion formed magnetite and chemical compound. The chemical compound can be different on every sample due to difference of contaminants in natural gas compound as gas turbine fuel and gas turbine working conditions. Magnetite in outer surface of sample test formed with a thickness below 1 mm.

Figure 7. XRD test result from the outer surface of bend tube preheater

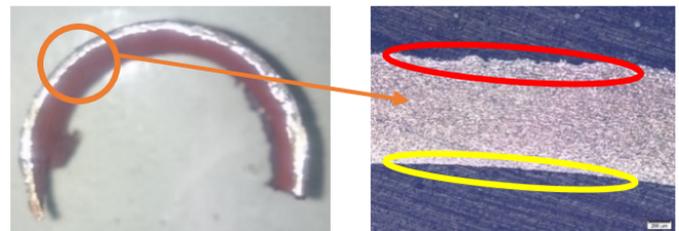
Figure 8. Microstructure analysis with 50x magnification

Microstructure test done with 3% Nital as etching reagent according to ASTM E407 [7]. The result of microstructure analysis with 50x magnification (Figure 8) showed a formed layer on inner and outer surface of bend tube preheater. The formation of red-brick hematite that occurred on inner surface of pipe marked by yellow circle on figure 8 with a thickness of about 7 micrometer or 0.007 millimeter. On the outer surface of pipe formed brownish-black that marked by red circle on figure 8 with a thickness of about 25 micrometer or 0.025 millimeter. With 50x magnification we can see oxide layer formed on inner and outer surface of bend tube preheater due to reaction of the specimens with working environment.

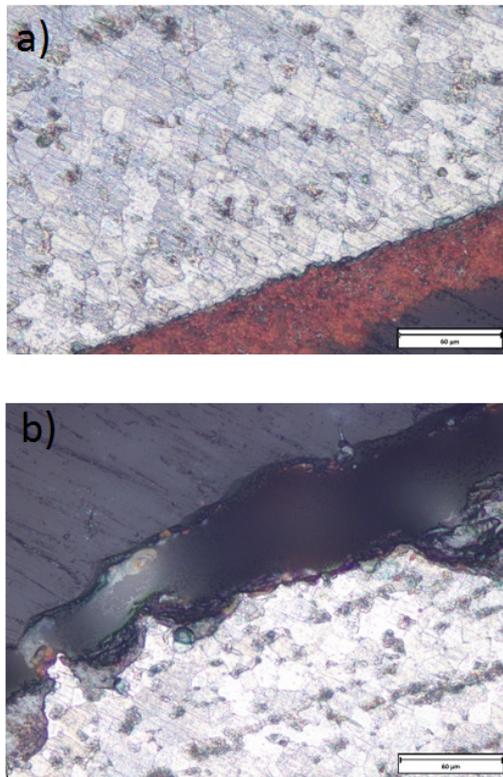
With 500x magnification on Figure 9a showed the establishment of hematite on inner surface with detailed image as marked with blue circle, there are not any indication that another oxide layer formed on inner surface. Figure 9b showed the establishment of magnetite on outer surface with detailed image as marked with green circle, there are not any indication that another oxide layer formed on outer surface. With 1000x magnification as seen on Figure 10, we can conclude that working condition and environment did not change any microstructural element of specimen. So we concluded that there are not any failure from working condition and operation. The

Figure 9. Microstructure analysis with 500x magnification (a) inner surface (b) outer surface of bend tube preheater

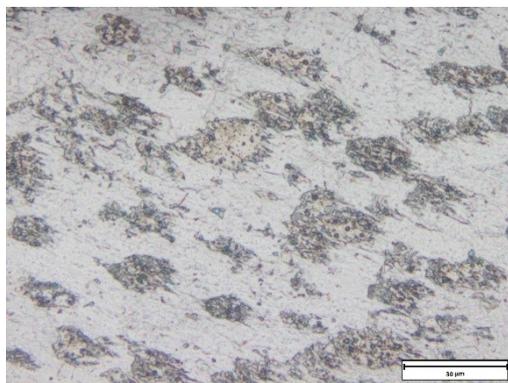
Figure 10. Microstructure analysis with 1000x magnification
