## Failure Analysis of Superheater Tubes Made from Material T91 in the Boiler of a 600 MW Power Plant

### Abstract

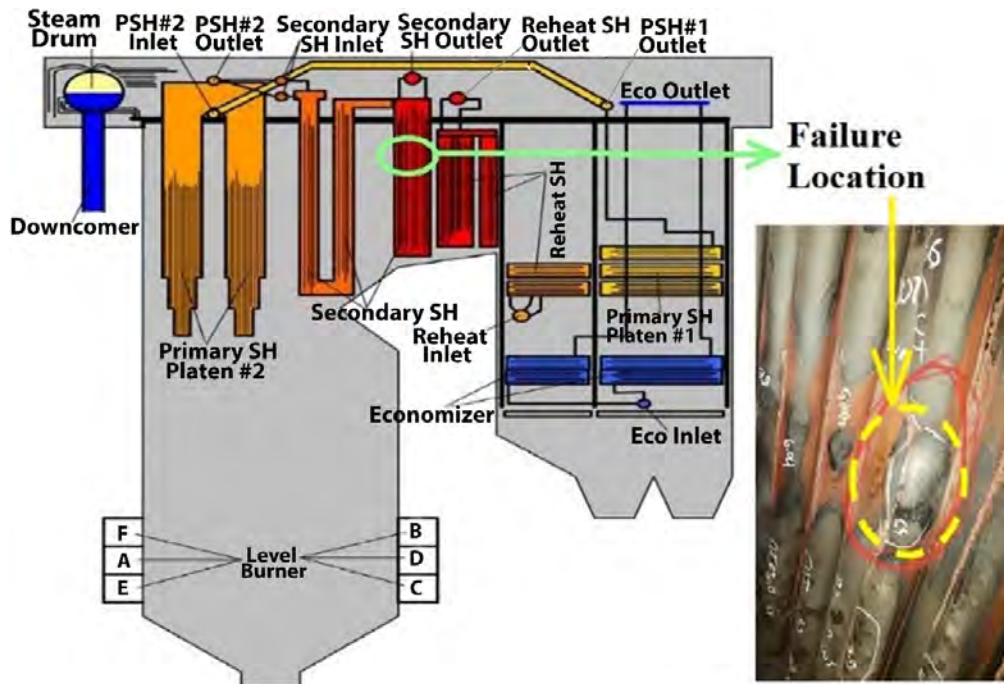
Figure 1. The location of failure tubes

In this paper, failure analysis of the superheater tube is comprehensively investigated with guidance of previous research and literature study. The research is based on events of tube failure that occurred twice in 2017-2018. Plant downtime more than 2 weeks for recovery. The location of both failures in the boiler is shown in Figure 1. Two

tubes failures in secondary superheater outlet at boiler 600 MW coal power plant. The tubes are made of alloy steel SA 213 T91 with the intended operating temperature of 540°C, which was applied continuously and the average steam pressure is 174 kg/cm<sup>2</sup>. The outer diameter (OD) of the tube was 50.8 mm and thickness 9.1 mm. The code of failure tubes is 6 and 7 with the location of failure respectively in the bank 11 row 8 and bank 11 row 11 of the secondary superheater outlet bundle.

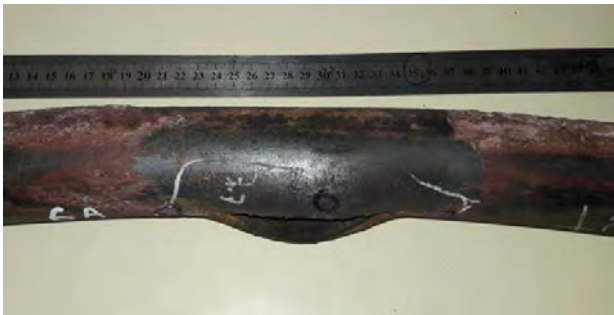
Visual inspection of the material is the first step used to identify the initial failure of the material. Visual examination is conducted on the failed superheater tube. In tube code 6, where the thick lip fish mouth failure type occurs, and the tube is exposed exceeding the operating temperature limit for a long time, it is ensured that creep

is the only mechanism causing the damage. This is showed by the tube walls are not experiencing thinning or plastic deformation, and there is no material flow. Overheating occurs in the tube caused by a deposit slagging thick on the outer wall of the tube so that there is uneven heat distribution on the tube . Visual inspection of tube code 6 is shown in Figure 2, and tube code 7 is shown in Figure 3. The opening burst tube of the tube with code 6 has a size of about 8.5 cm and a width of 5 cm, it is shown by Figure 2a. The damage type of this tube is a thin-lipped rupture with narrow open bursts that crack in the longitudinal direction and occur site (swelling), it is shown in Figure 2b. The tube walls have experienced relatively even thinning. Wall thickness of the rupture lips/edges are between 1.37 – 3.13 mm, shown in Figure 2c. Dimensional measurement

(a) The dimension of failure

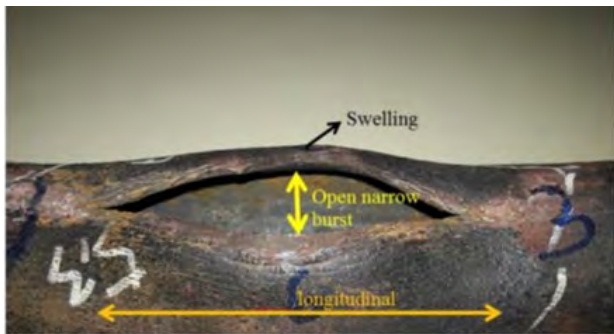
(b) The failure characteristics

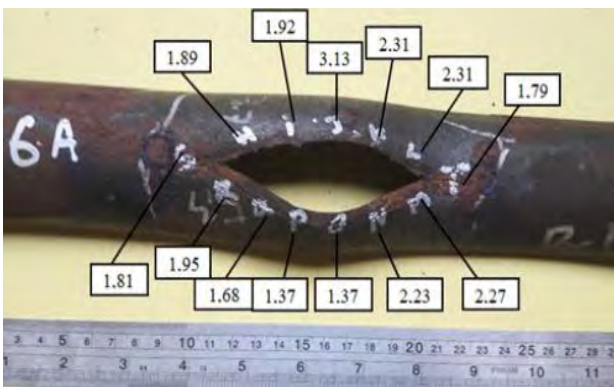
(c) The tube thickness of the rupture area in mm

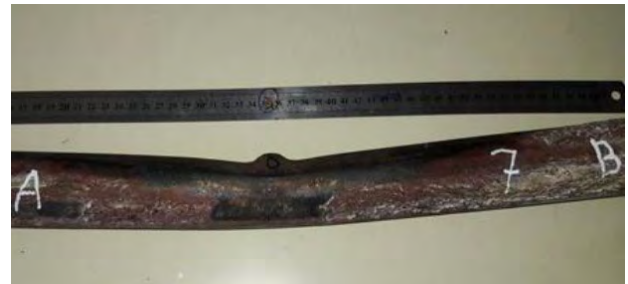
The opening burst tube size of the tube with code 7 has a size of about 3.5 cm in length and 7 cm wide, shown in Figure 3a. Thin lip-type tube damage where thinning occurs starting from the outer wall of the tube and the presence of an oxide layer indicating the mechanism of damage that occurs is erosion and corrosion. The tube has the failure of thin lip fish mouth rupture type and a wide opening (fish mouth) burst, shown in Figure 3b. It is shown from the thickness measurement where localized thinning occurs in the rupture area. Wall thickness of the rupture lips/edges is between 0.90 – 2.89 mm. It is shown in Figure 3c.

(a) The failure tube with tube code 7

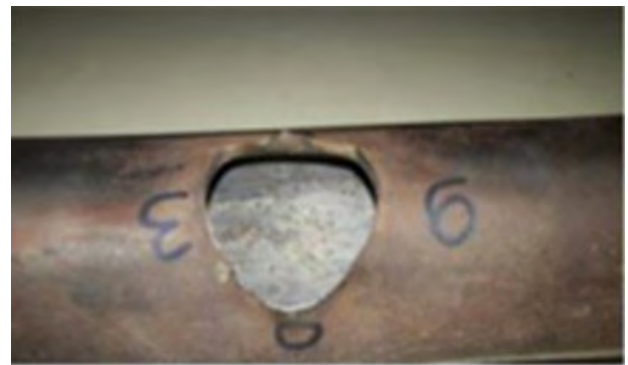
(b) The oxide layer failure characteristics tube with tube code 7

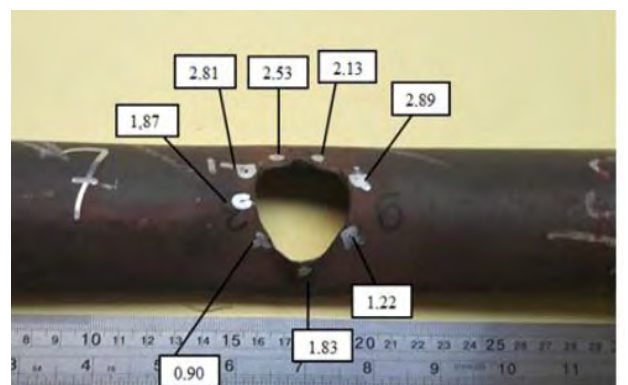
(c) The tube thickness of the rupture area in mm

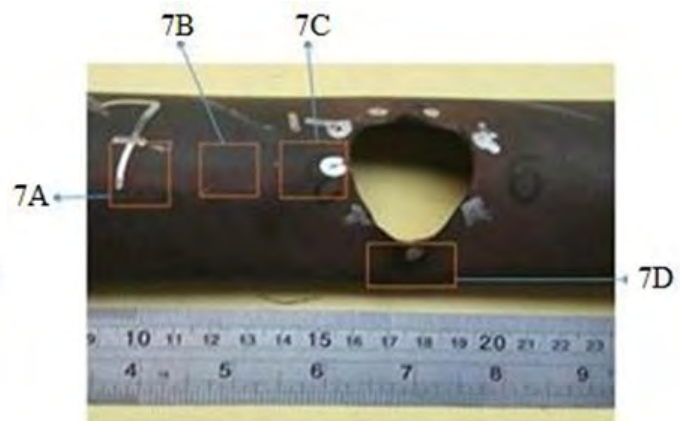
**Figure 5.** Sample location for hardness test and microstructure analysis of tube code 7

Sample location for hardness test tube with code 7 taken from the part as shown in Figure 5. The hardness on the tube with code 7 is shown in Table 3. This shows the variation in the level of hardness on the rupture lip area, and that is away from the rupture lip. There is a significant difference in the hardness value which indicates that there has been a change in the microstructure and there is also localized overheating in the area of the damaged lip. This can be seen from Table 3, in which the estimated metal temperatures indicated that the tubes had experienced higher-temperature operation above 800°C.

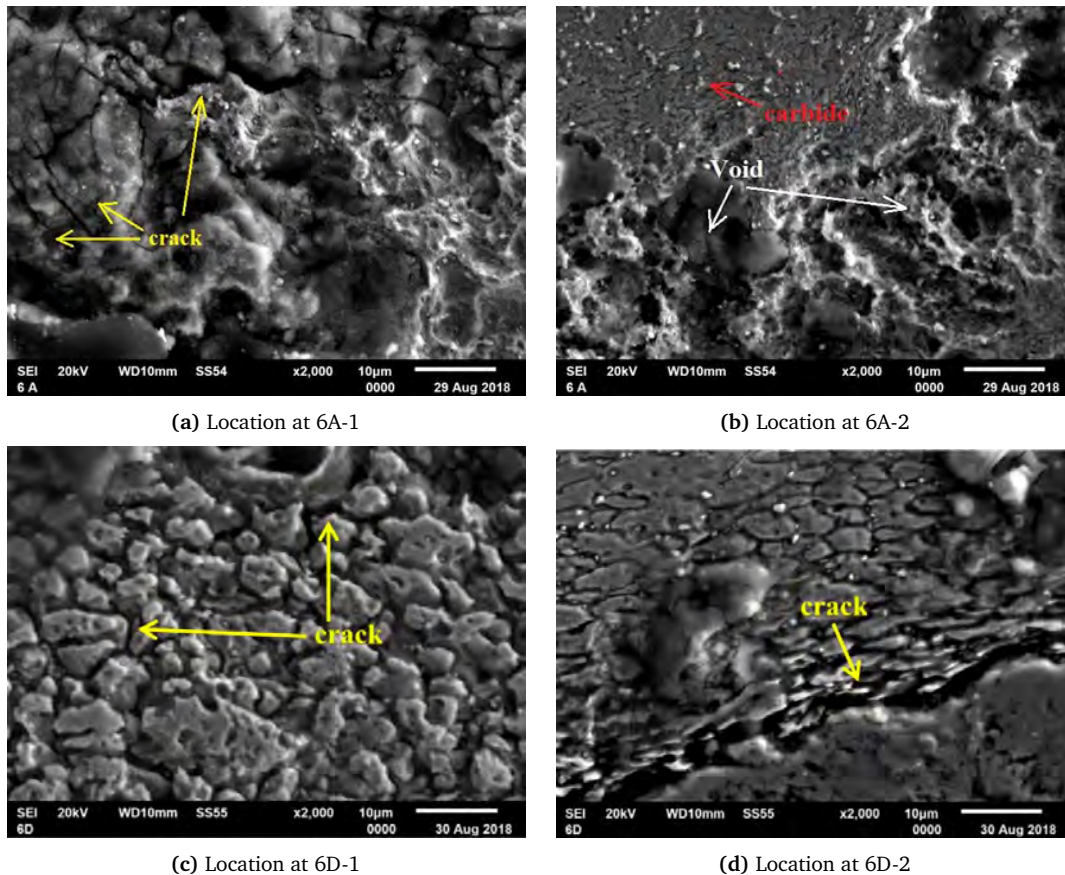
**Figure 6.** Microstructure of SEM tube code 6

Sample location for analysis of microstructure tube with tube code 6 taken from the part as shown in Figure 4. Observations were carried out under the electron microscope (SEM). Observations in sample tube code 6 were made at location 6A, which was a bit far from the damaged area, and location 6D (which was a broken area). Figure 6a and 6b shows the presence of grain boundary (intergranular crack) and creep voids. The extreme conditions of the grain boundary cracking are shown in Figure 6c and 6d, which are damaged areas.

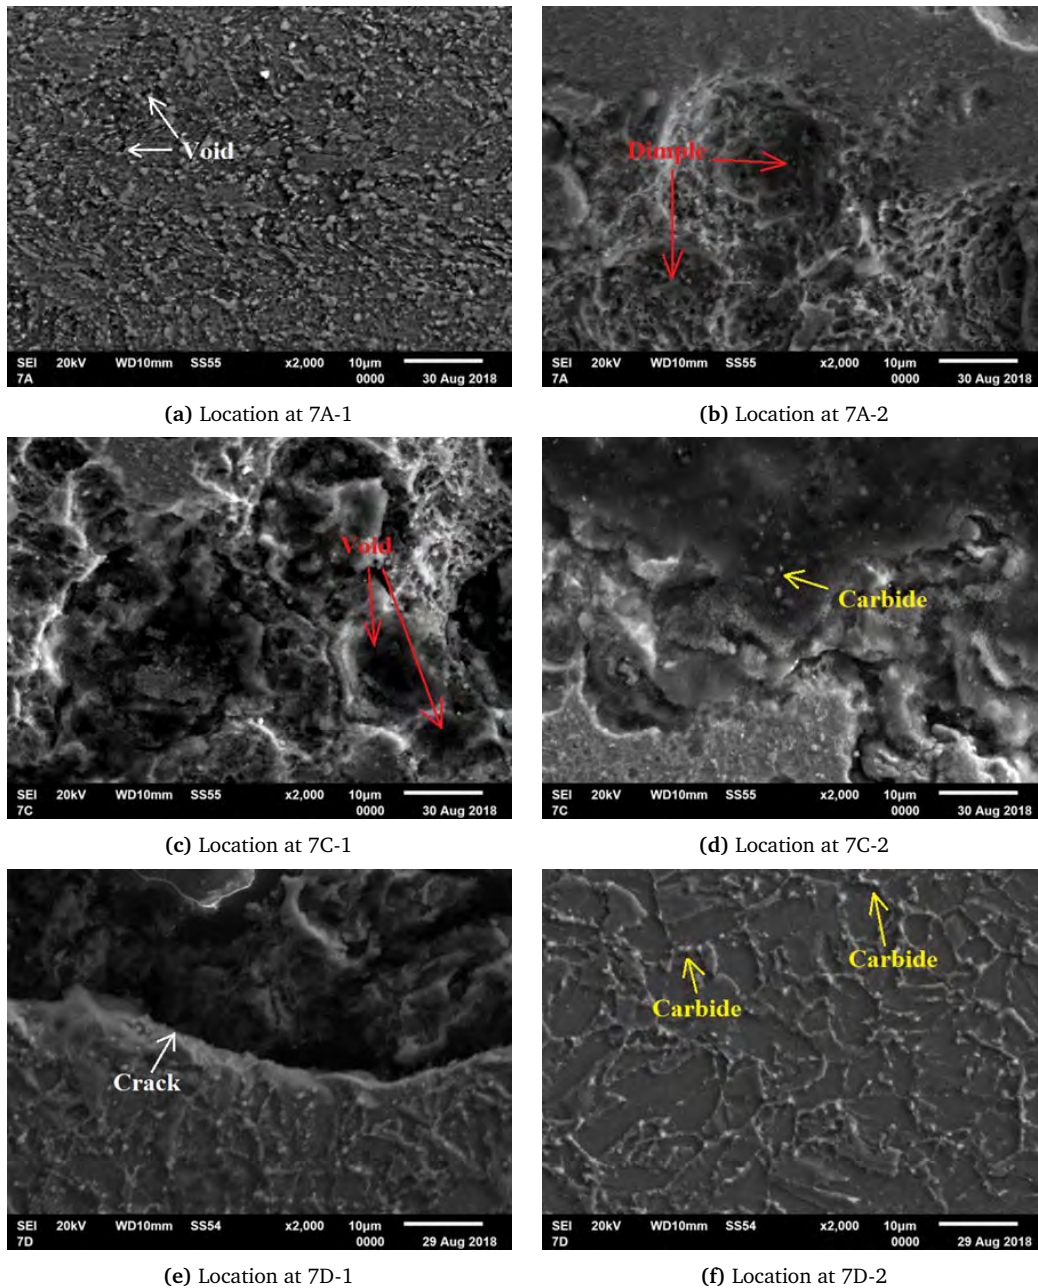
Figure 7. Microstructure of SEM tube code 7

Figure 7a to 7f shows the results of microstructural observations using SEM at locations 7A, 7C, and 7D. The micro-structures on the samples of 7C and 7D (Figure 7d and 7f) shows of rounding/spheroidization of M23C6 (indicated with a yellow arrow). Figure 7 also shows the void (Figure 7a) formed along the grain boundary and form a crack (Figure 7c, showed with a white arrow). The rupture area (samples of 7C and 7D) shows void as it relates to one another (interconnected voids) occurring during operation. The void is a sign of creep damage that grows/develops at high temperatures. Local temperature increases above the allowable temperature limit caused by grain boundary sliding. The shift results in a decohe-

sion/void of grain. In line with time, voids grow and become joined to each other. This results in a decrease in grain boundary strength and a decrease in the component ability to accept loads. Then the temperature increase in the tube wall affects the rounding of the carbide, voids [3], and softening of the material marked by hardness level reductions. This phenomenon will reduce the strength of the material and result in a flexible/soft fracture which is indicated by the rupture of the dimple (Figure 7b and 7c, red arrows).

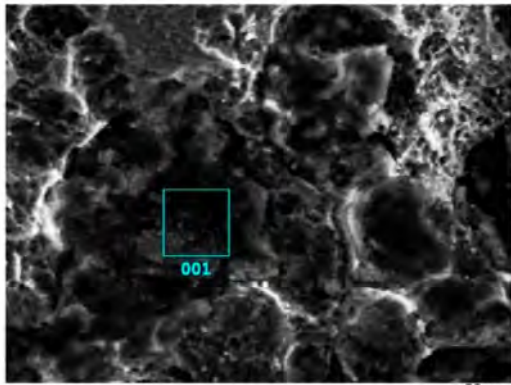
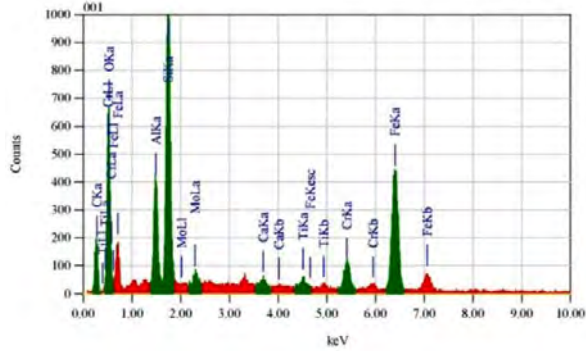
(a) Location 7C

The result of the qualitative analysis of SEM-EDS in Figure 8, shows the corrosive elements of Si and Ca. The presence of such elements indicates that a corrosion attack is caused by a mixture of ash particles which mostly composed are iron oxides and hydroxides elements. The result of SEM-EDS in Figure 8 also detects the existence of elements Al, Fe, Ti, and V. The material content in coal is very diverse, such as moisture, volatile matter which is an active substance found in coal, consisting of flammable gases such as: methane ( $\text{CH}_4$ ), hydrogen ( $\text{H}_2$ ), carbon

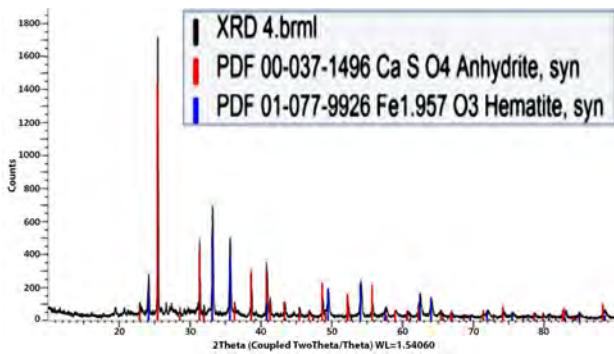
The presence of CaSO<sub>4</sub> is shown by the results of the X-ray diffraction test against the scale taken from the tube surface, as shown in Figure 9a. The results of XRD analysis on the deposit scale/slag shown in Figure 9b prove the deposits of slag also have corrosion products in the form of iron oxides and hydroxides.

(a) The presence of CaSO<sub>4</sub>

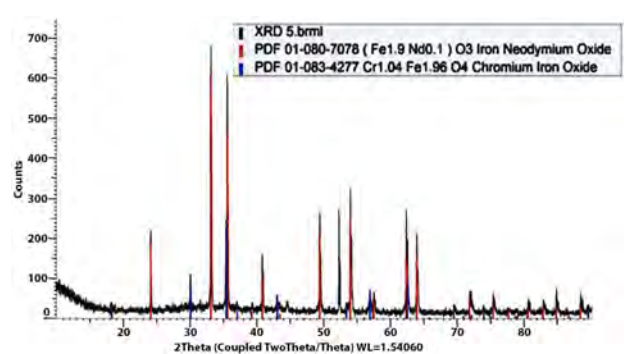
(b) The presence of iron oxides and hydroxides
