# Georadar Application for Dam Safety Study (Case Study of Selorejo Dam)

Teguh Winari<sup>1</sup>, Kamsiyah Windianita<sup>1</sup>, and Fahmi Hidayat<sup>1</sup>

**Keywords** – Dam, seepage, georadar, anomaly

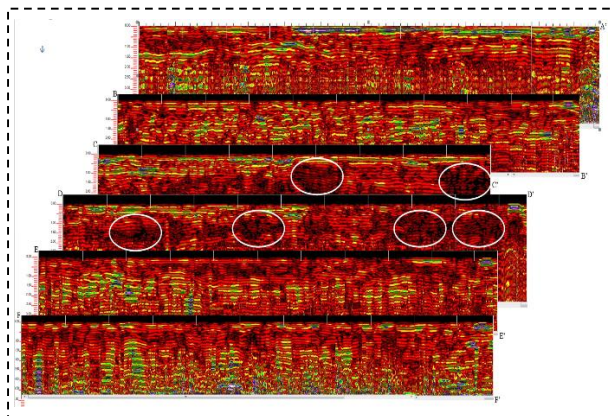
**Figure 4.** The georadar measurement result of longitudinal path A - A' to F - F'

The georadar measurement result of longitudinal path can be seen at Figure 4 and Figure 5. With a track measurement length of 32 m, georadar can detect until the depth of about 4 m. The radargram result on this soil stack shows a domination of layer discontinuities. This is due to material density variation that is displayed through bright colors, red and black. This bright color appears in all tracks with random spread and dominating that indicates a higher density than red and black area. The almost black and black colors show a weak zone. This weak zone is dominant on track C-C' and D-D' (white circle), and in other tracks it appears as small and local spots. The unconformity on some radargram does not indicate a structure. This thing is considering to measurement on stacks so the possibility is the discontinued layer.

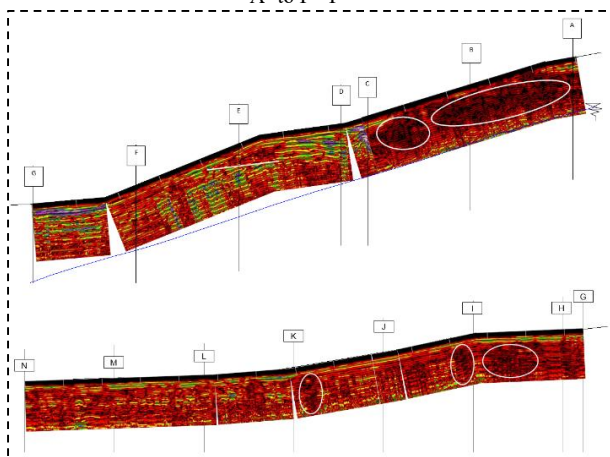
**Figure 6.** The measurement result of transversal path A - N

- a. A-N path (Figure 6), from point A to point C (about 15 m), around point I and point K
- b. O'-O path (Figure 7), around the point H and L - M
- c. P'-P path (Figure 8), random from point G2 to P
- d. R-R' path (Figure 10), random from G4 to R
- e. S'-S path (Figure 11), around point F5

There are also discontinuities (white line) on some tracks, such as track A-G, trajectory O'-G1, P'-G2 trajectory, trajectory Q'-G3, S'-G5 trajectory, and G5-S path. However, because the measurements are performed on the soil stack, discontinuities are not in the dam structure but it is less-well dense material.

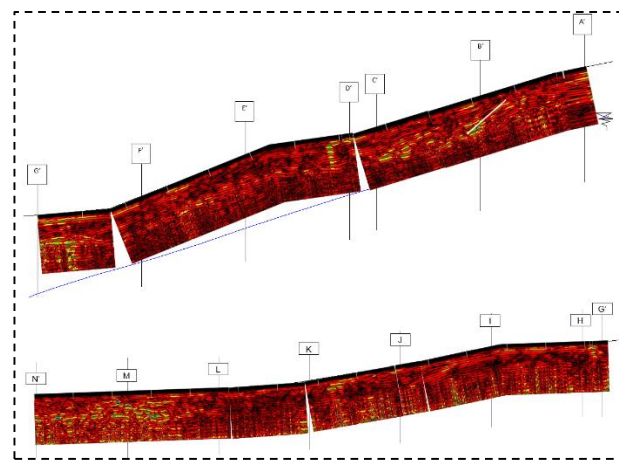
Figure 12. The measurement result of transversal path A' - N'

Radargram in transversal path shows the embankment material that is divided into two layers, with the inter-layer at a depth of 1.5 m. In one track there is upper part which is denser than the bottom, and some are otherwise. The denser top is described with a lighter color (purple-blue-green-yellow) located on the upper layer of 1.5 m, while the lower part is black or dark red. There are some weak zones (white circle) that is shown by georadar measurement result in transversal path :
