Analysis of Embankment Slope Failure And Effectiveness Of Reinforcement With Full Displacement Column on Soft Soil (Case Study : Construction Of Padang Sicincin Toll Road Section STA 7+400 – 7+550)

Keyword : Embankment, Back Analysis, Full Displacement Column, Soft Soil

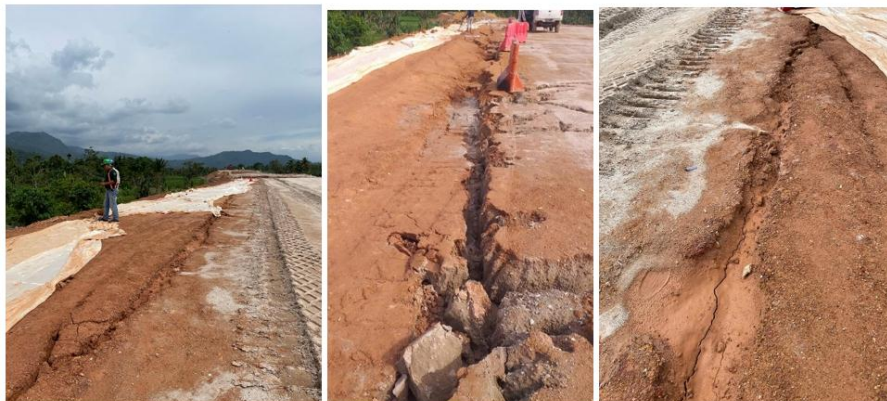
One of the problems in the construction process in this package is the landslide of the preloading embankment at STA 7+450 on the right side, which is indicated due to a decrease in the embankment subgrade. This landslide resulted in a construction process that could not continue, resulting in a delay in construction progress. This landslide caused a delay in the construction progress because handling had to be carried out on the embankment that experienced the landslide. In addition, the embankment is one of the access roads from small to larger stationing that has potentially been late due to the landslide that occurred. Based on the documentation in Figure 2 and Figure 3, there are cracks on the top surface of the embankment and there is heave/bulging at the end of the right embankment toe that indicated embankment was collapsed.

Figure 2. Cracks on the top surface of embankment STA 7+450 R

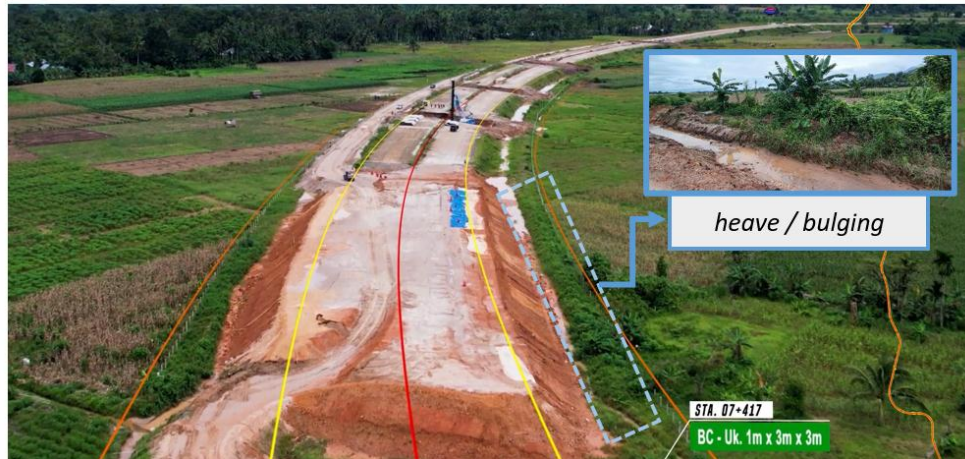
Figure 3. Heave at toe of embankment STA 7+450 R

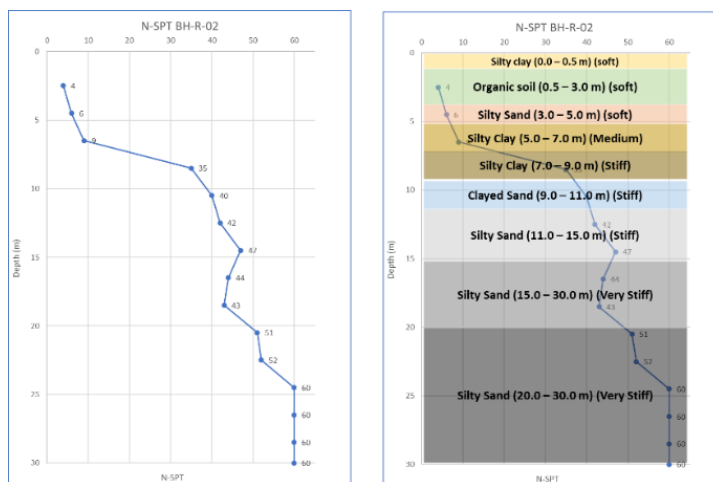
The main data used in the analysis of the embankment slope failure is the Boring log results (N-SPT) and data from the soil laboratory test. According to the project, the closest soil data is located at STA 7+364, namely point BH-R-02. The boring log data of point BH-R-02 and the results of the interpretation of soil type can be seen in Figure 5.

Figure 5. N-SPT value from Boring log

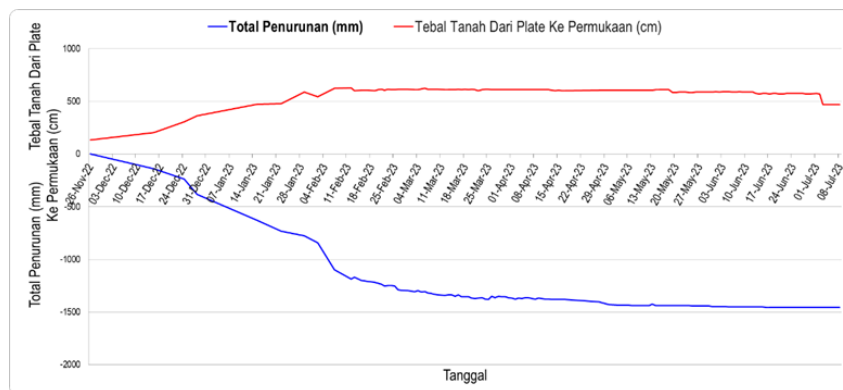
As monitoring instruments on the site, the project team used several geotechnical instrumentation tools such as Piezometer, Settlement Plate, and Inclinator. The results of these instrumentation readings were used as modeling validation and reference lifts for the addition of embankment loads in the finite element program. The monitoring results based on these three geotechnical instruments are shown in Figure 4 for Piezometer and Inclinator then Figure 7 for the settlement Plate.

Figure 7. Result of monitoring settlement from settlement plate

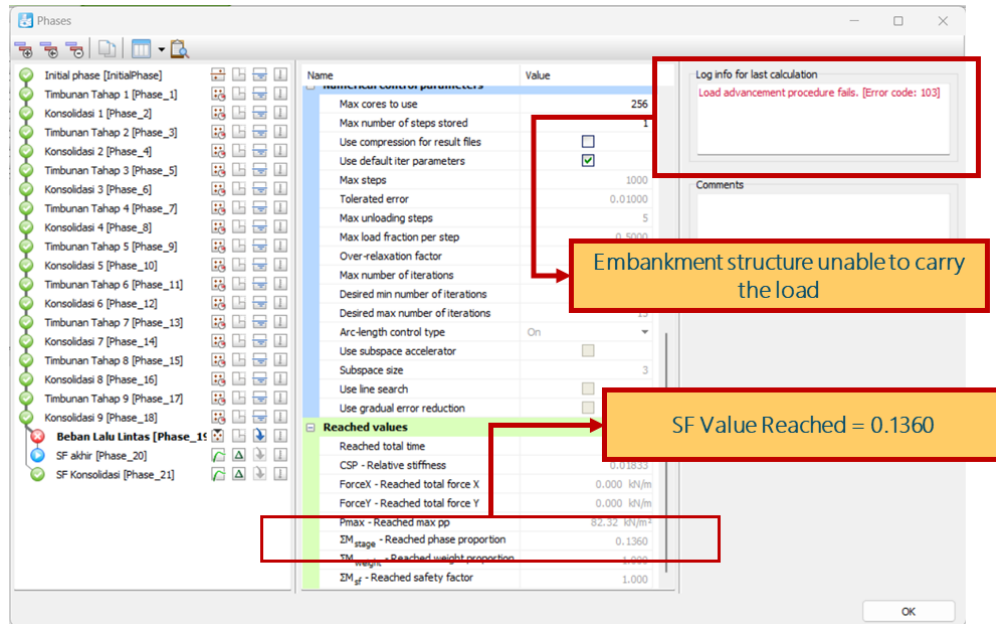
From the modeling of stage construction, a critical SF value of 1.028 is obtained in the condition where the embankment reaches the maximum height of 6.291 meters shown in Figure 5. 15. Then the SF value is less than 1 under the condition that the embankment soil is passed by the traffic load. As known in the background this embankment is one of the mobility paths for project vehicles that are shown in Figure 9.

Figure 9. Staged construction on the modelling program indicated the embankment failure at the traffic load stage

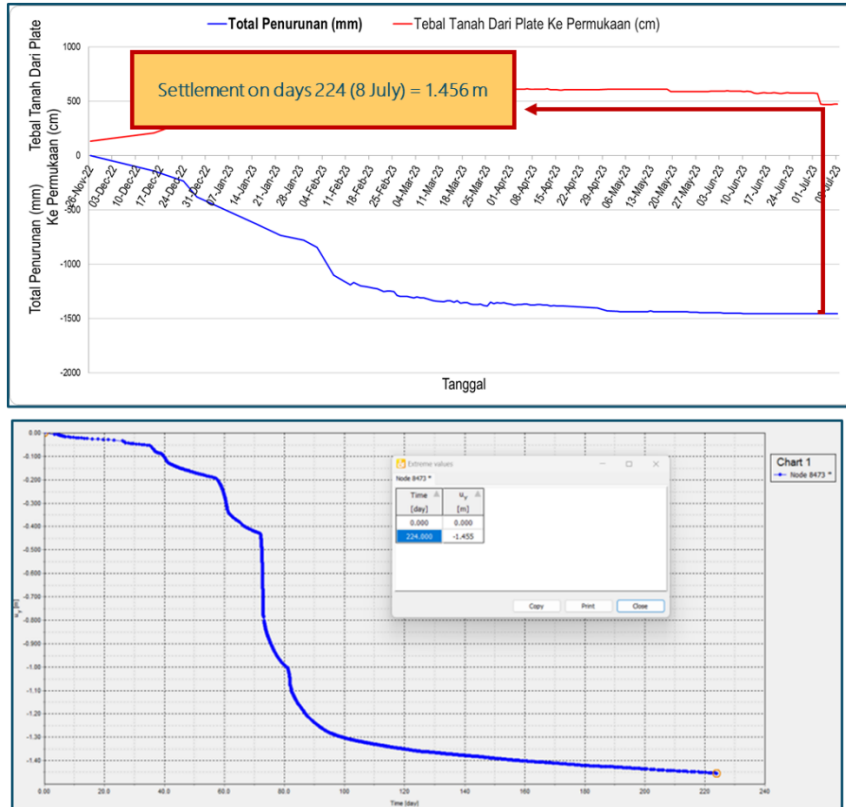
Based on the settlement results, the settlement value is almost the same as the condition in the field. Monitoring of settlement in the field was carried out with geotechnical instrumentation media in the form of settlement plates. The decline that occurred in the field monitored using the settlement plate was read in the period November 26, 2022, to July 8, 2023. The last monitoring result, on July 8, 2023, obtained the value of the decline that occurred was 1,456 meters. While the results of modeling with finite elements obtained a settlement value of 1,455 meters. A comparison between the results of this settlement can be seen in Figure 10.

Figure 10. Comparison settlement from field data and modelling

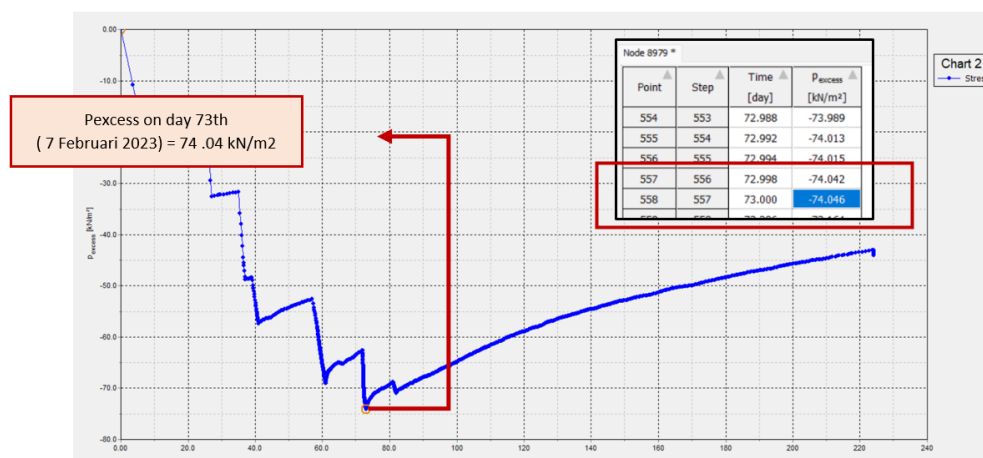
With consideration of pore water pressure as a validation of the back analysis results, readings from geotechnical instrumentation in the form of piezometers installed in the field at a depth of 2 meters below the subgrade are used here. Based on the modeling results, the maximum pore water pressure value is on day 73 with a value of $P_{excess} = 74.04 \text{ kN/m}^2$ according to the graphical output of the finite element program with the same observation point as the piezometer location shown in Figure 13. As for the piezometer readings, the readings obtained on day 73, on February 7, 2023, have a value of 78.86 kN/m^2 shown in Table 4. From both modeling results and piezometer readings in the field have similar pore water pressure values, this indicates that the soil model and parameters used in modeling are close to field conditions.

Figure 13. Pexcess output from modeling
