The Improvement of Existing Slope Reinforcement System and The Design of Alternative Slope Reinforcements Case Study: Lainea-Awunio Road Section Km 98+050 South Konawe Regency, Southeast Sulawesi Province

Nadia Kamila^{1, a)}, Mohamad Khoiri^{2, b)} & Freddy Siagian³⁾

¹⁾Magister Student, Department of Civil Engineering, Institut Teknologi Sepuluh Nopember (ITS), Surabaya, Indonesia.

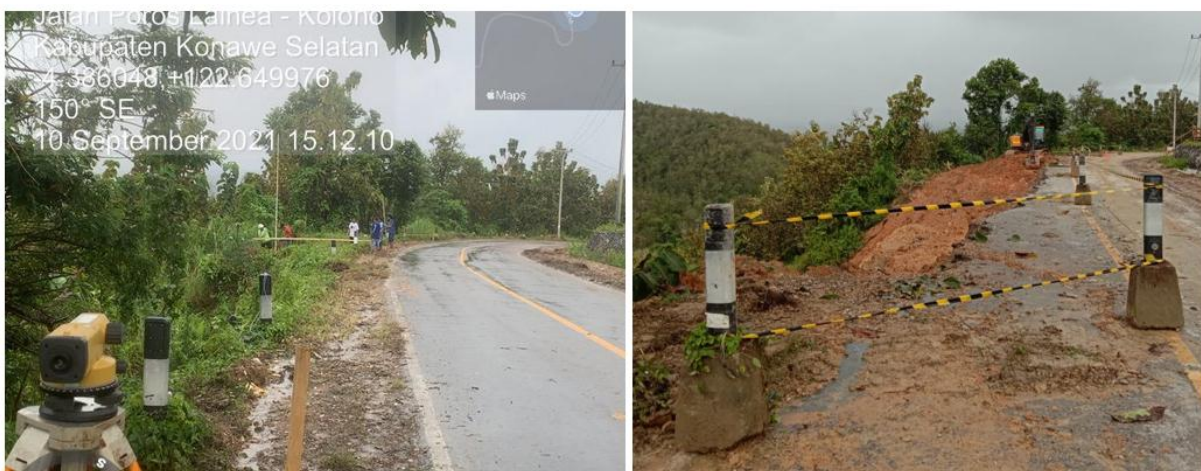
Figure 2. Slope condition before and after landslide (PPK 2.1, 2021)

The Lainea-Awunio road section is one of the national roads in Southeast Sulawesi Province in South Konawe Regency, one of the slopes on the Lainea-Awunio road section, precisely at KM 98+050, location of the landslide are shown in Figure 1, has experienced a landslide in 2021 during the rainy season that caused almost half of the road to collapse and block the flow of traffic for this reason slope rehabilitation has been carried out using the construction of retaining walls as high as 8.5 meters. A slope, both embankment slope, excavation slope, and natural slope must be designed to be stable and safe because unstable slopes can potentially lead to landslides that can cause damage to the infrastructure built on it (Shoffiana et al 2022). The condition of the slope before and after the landslide can be seen in Figure 2 and the condition of the slope after the reinforced is shown in Figure 3.

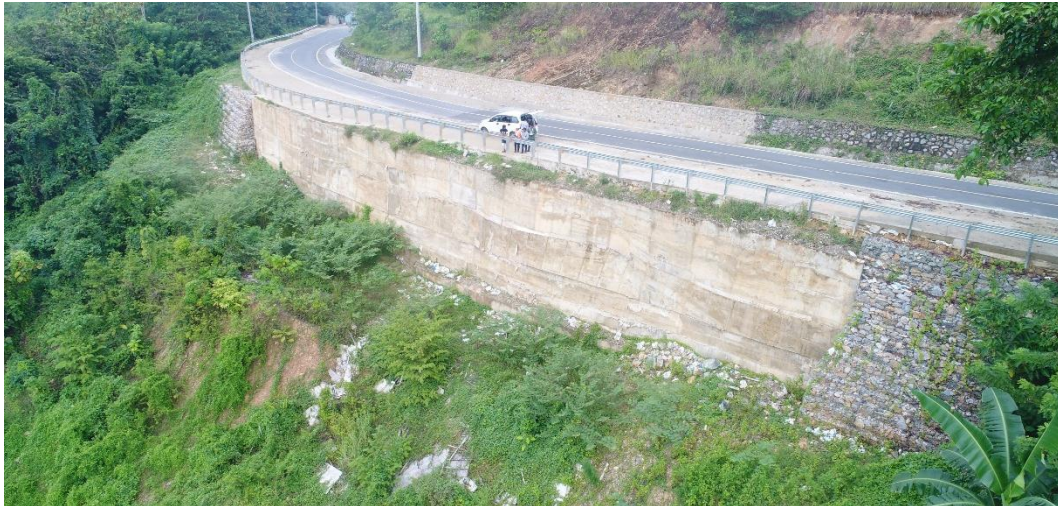
Figure 3. Condition of slope after the reinforcement

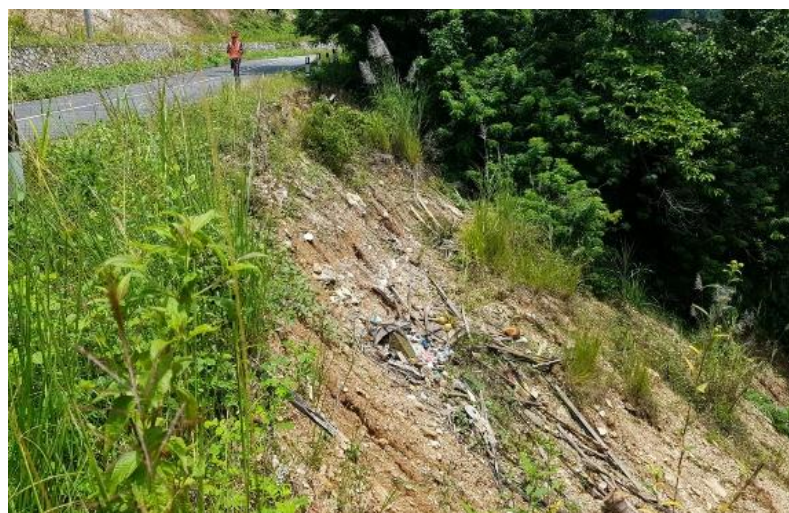
Figure 4. Cracks on the slope
(PPK 2.1, 2019)

Amalia et al (2018) in her research of slopes in the construction area of the East Kalimantan Police Criminal Investigation building, Balikpapan which has slopes with fairly stiff soil shows that the analysis of slope stability in saturated conditions due to rain with original soil data that is predicted to be safe ($SF > 1$) turns out to be a landslide ($SF < 1$) when analyzed for slope stability with the crack soil approach, where the condition of the landslide is in accordance with the conditions that have occurred in the field. The cracked soil approach is a theory of landslides that occur due to cracks on the slope surface. To accommodate the property of cracks that can drain water easily, the soil strength along the cracks should be considered equal to the soil shear strength in the drained condition, where the cohesion value (c) = 0 and the internal friction angle (ϕ) \neq 0; regardless of the original condition of the soil (Amalia et al 2018). Based on the Geological Map and test results, it was found that the soil at the location has a high soil bearing capacity, but in reality, landslides occur in the field during the rainy season and cracks are found on the slopes (Figure 4) therefore it is necessary to analyze slope stability using a cracked soil approach.

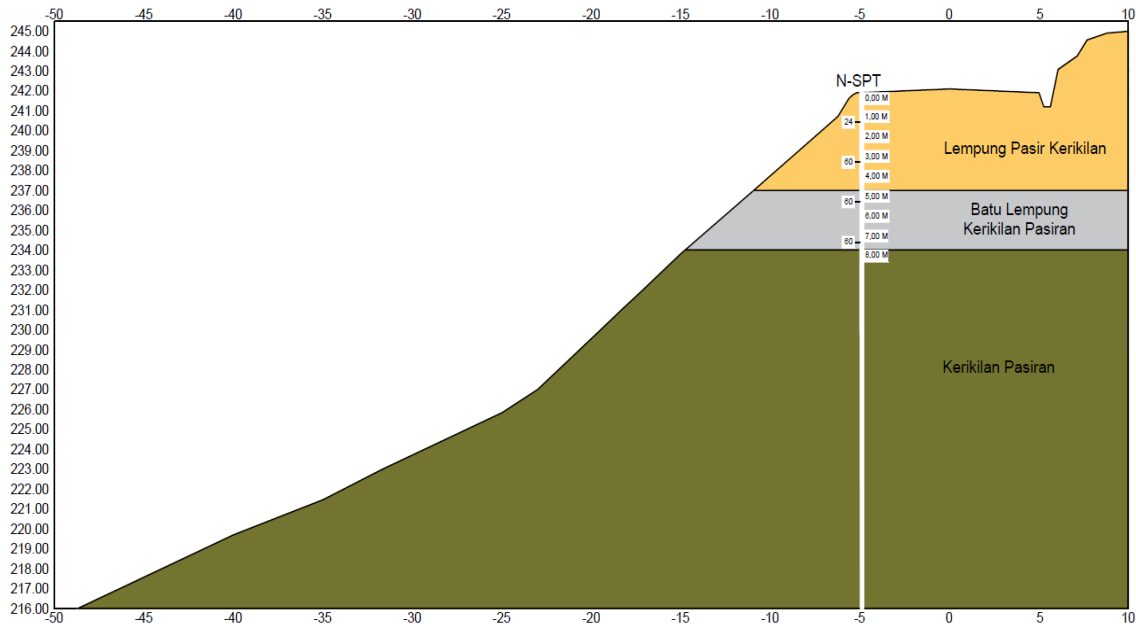
Figure 6. Existing slope stratigraphy

Soil properties in these studies is determined by correlation, boring test, and laboratory test results based on primary and secondary data. The soil parameters are shown in Table 1, and slope stratigraphy for modelling are shown in Figure 6 and Figure 7.

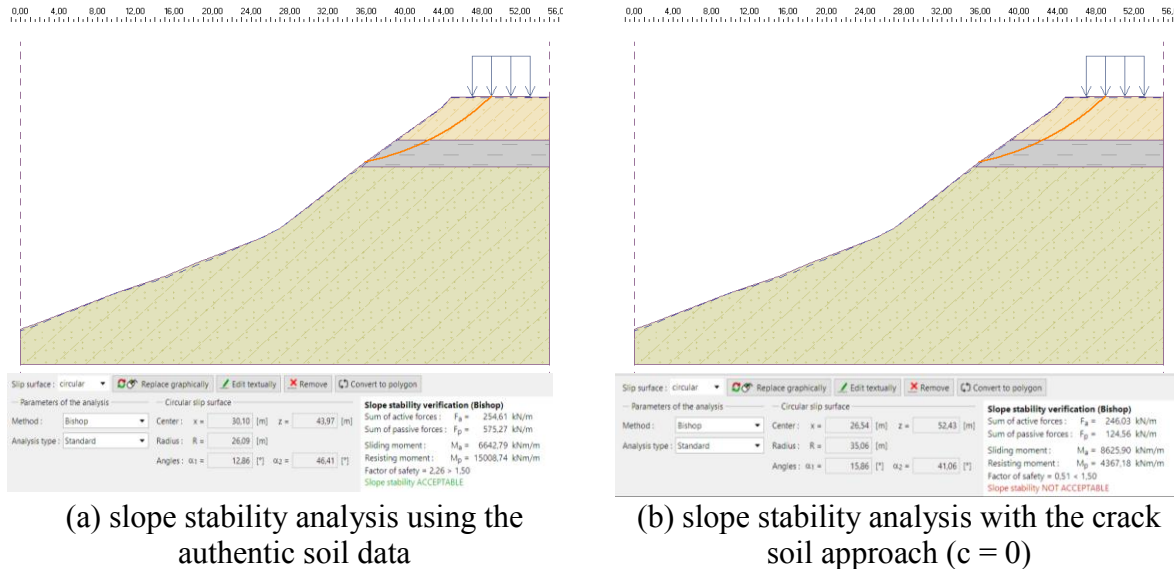
Figure 8. Slope stability analysis of existing slope

The results of the slope stability analysis using the authentic soil data obtained a value of SF = 2.26, while the slope stability analysis with the crack soil approach (c = 0) resulted in SF = 0.51 (Figure 8). The slope is said to landslide when the resulting SF is less than SF = 1 (critical), so it can be deduced that the slope stability analysis with the crack soil approach illustrates the condition of the landslide in the field.

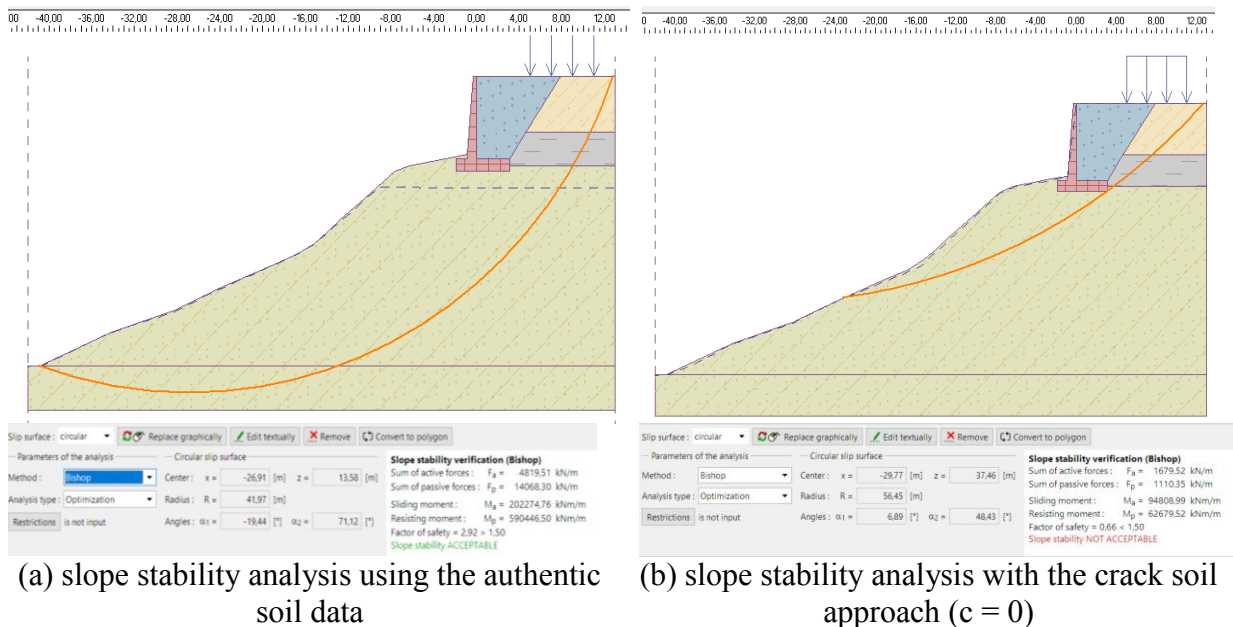
Figure 9. Slope stability analysis of reinforced slope

From the analysis it can be concluded that for retaining walls examined with authentic soil data have a safety factor $SF > 1$ and meet the safety criteria, which means the stability of the slope meets the requirements and there is no landslide occurred. However, when examined with the crack soil approach, the retaining wall has a safety factor of $SF > 1$ but does not meet the safety criteria for stability lateral sliding and global stability. As for global stability, the crack soil approach has a landslide plane with a safety factor value of $SF = 0.66$ (Figure 9) so additional reinforcement is needed to mitigate the landslide plane.
