Water Quality Analysis of Village and Monitoring Well around Rembang Steam Power Plant (EIA in Central Java, Indonesia)

Abstract— Water quality sampling and monitoring of village well as a regular monitoring each quarter in a year for Rembang Steam Power Plant 2 x 315 MW was one part of EIA implementation study. This research aim to analysis the most impact occurrence that forecasted as a hypothetical important impact which is cause environmental change base on water quality sampling and monitoring from operational activity in first quarter (TW 1). Implementation method was used water sampling in 2(two) resident well and 6 (six) monitoring well in Trahan and Leran village, then the water sample was analyze in laboratory refer to the raw quality which has been set. The monitoring result on the residents wells quality was generally known that in the Trahan village residents wells (AB-1) found parameter that exceed quality standard i.e. total dissolved solids (TDS, come from river seepage and rainfall runoff), Chloride and Hardness, the high concentration some parameters, both exceed the quality standard as well as have a high critical level, generally was not caused by the operation

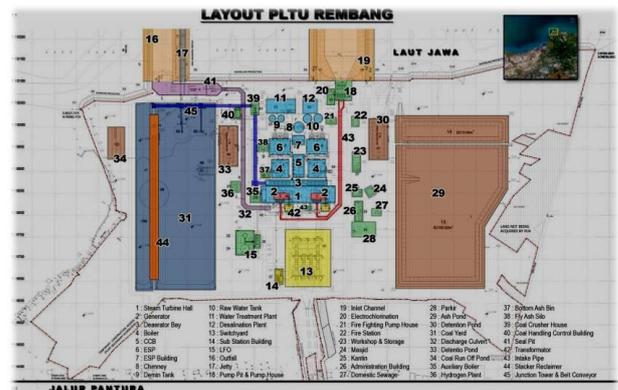
Figure 1. Layout of Rembang Steam Power Plant 2 x 315 MW

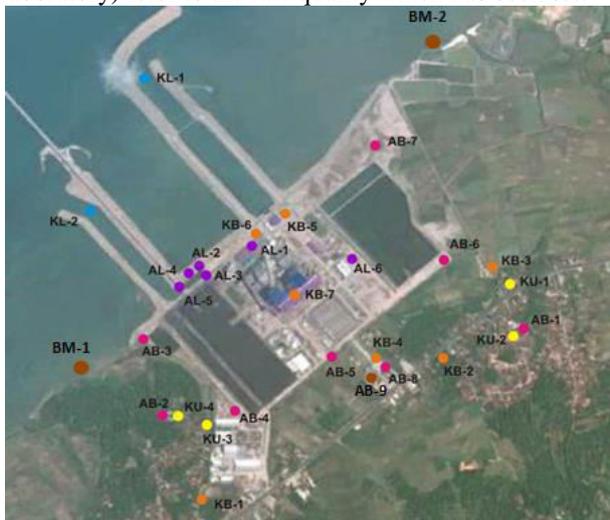
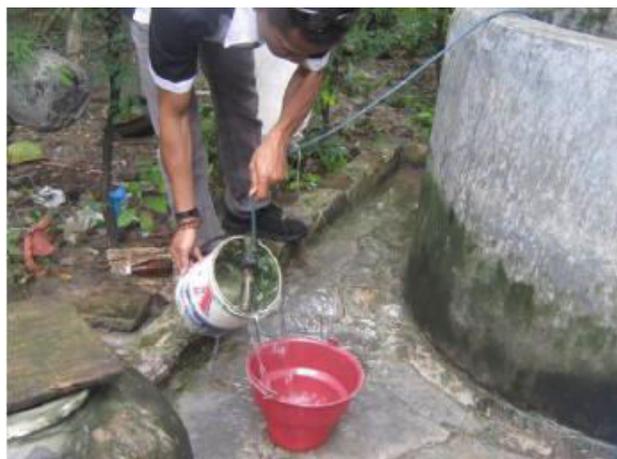
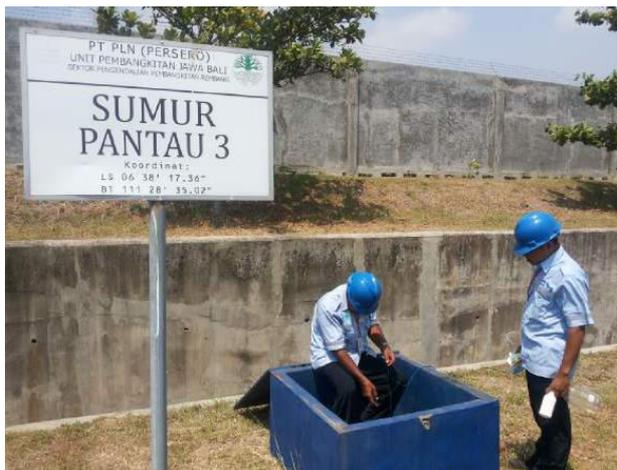
Figure 2. Water sampling for resident and monitoring well in Leran and Trahan village (AB-1 until AB-8)

Research was carried out in Trahan village and Leran village. Water sampling was done in 2 (two) resident well and 6 (six) monitoring well then the water sample was analyze in water quality laboratory (PJT 1 laboratory) refer to the raw quality which has been set.
