Nondestructive Evaluation of Masonry Materials used in Historic Philippine Structures

Mathew Harvey T. Peralta

Institute of Civil Engineering, University of the Philippines Diliman

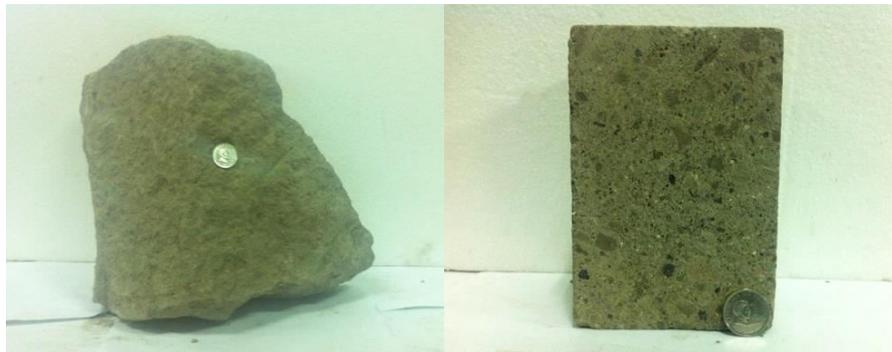
Figure 2. Images before (left) and after (right) cutting of the MC 6 specimen

Samples from the Manila Cathedral and the San Ignacio Church Ruins were gathered and transported to the Construction Materials and Structures Laboratory (CoMSLab) at UP Diliman. After letting them rest at room temperature for 2-3 days, the specimens were then cut to size using the diamond blade cutter at the CoMSLab. The samples were cut to a square cross-section with 100 millimeter sides and a height of 150 millimeters to be able to keep a 1:1.5 width to height ratio while keeping the minimum path length for the ultrasonic testing. As an example, the images before and after cutting of the 6th specimen from Manila Cathedral are shown in Figure 2.

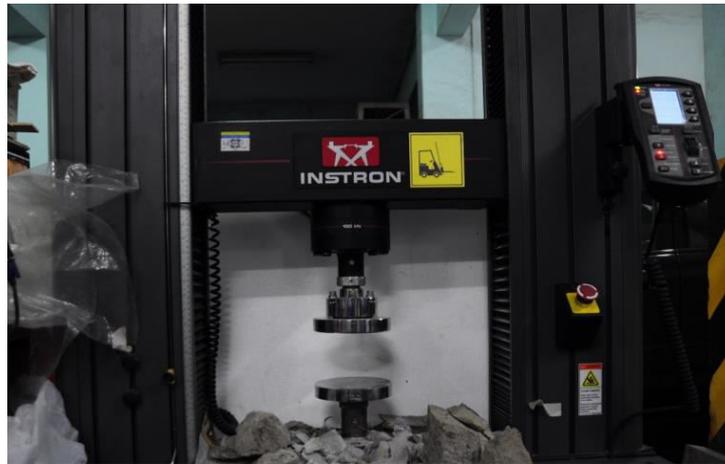
Figure 4. Instron 5982 floor model 100 kN capacity Universal Testing Machine with the control panel shown on the upper right.

After going through ultrasonic testing, the specimens underwent destructive testing. The Instron[®] 5982 floor model 100 kN capacity Universal Testing Machine was used. The equipment comes with a computer interface through the program Bluehill[®] 3 that allows the user to input the specimen geometry so that it instantaneously obtains the stress based on the load applied. The interface also displays the stress-strain curve as the compressive test goes on. For the test itself, ASTM C1314-12, or the Standard Test Method for Compressive Strength of Masonry Prisms, allows any convenient rate of loading to be used as long as the failure happens between 1-2 minutes. Since the equipment allows for

numerous parameters to be taken, the compressive stress at yield and the Young's Modulus of Elasticity were selected as those that will be computed and reported in the output file of each test because these are the parameters to be studied in this research. An image that shows an example of the set-up is shown in Figure 4. An image was taken directly after testing. An example of an image of a specimen after testing is shown in Figure 5.

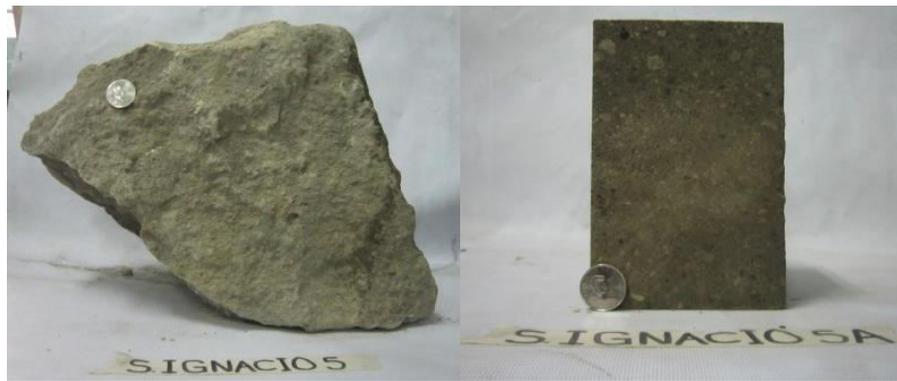
Figure 10. Images before (left) and after (right) cutting of the SI 5 specimen

Again, due to the limited number of specimens that were obtained, the coefficients of determination of the multiple non-linear regressions all equaled to one. Fortunately, for the case of the San Ignacio materials, an additional sample (SI5) was allowed to be taken. Images of this sample before and after cutting to size are shown in Figure 10. The sample was tested in the same manner as the other ones, and the same parameters were taken. This was done to try to verify the applicability of the correlations obtained for the samples. This tests the different equations obtained and the effects of the difference in size, and essentially the path length of the wave, on the predicted results. The actual compressive strengths and Young's Moduli of this specimen, as well as the values of the NDT parameters are given in Table 7 while the results of the verification are shown in Tables 8.
