Investigating the Motions Behavior of a Ferry in Waves Caused by Damaged Conditions

Abstract— a progressive flooding-ingress of water to a compartment of a damaged ship affects the motions of a ship. In this present study, the behavior of the motion of a ferry caused by damaged conditions in waves was investigated through the experimental work. The leakage of compartments was made into several scenarios including one, two, and three damaged compartments, and the damaged ship model was simulated in heading and beam waves. The research results show the one damaged compartment on the engine room (ER) affected extreme stern trim as well as Void No.1 affected extreme bow trim. The two damaged compartments on the water ballast tank (WBT) No.2 and Steering gear room (SGR) resulted in extreme stern trim as well as WBT No.1 and Void No.1 affected extreme bow trim. The heave, pitch, and roll responses on the damaged Void No.1 are higher comparing with the damaged ER. Also, the heave, pitch, and roll responses on damaged SGR and WTB No.2 are higher than Void No.1 and WBT No.1. The peak resonances of heave RAO on bow trim affect higher magnitude than on stern trim. Pitch or roll RAO caused by

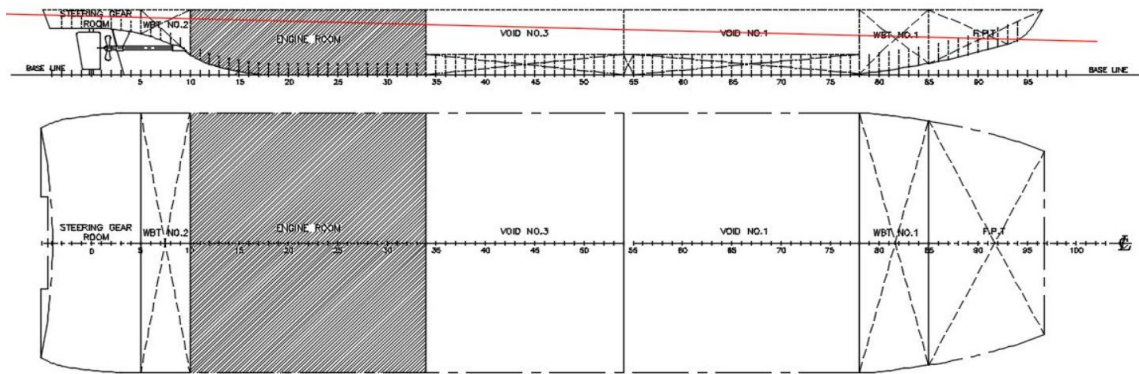
Figure 5. Damaged engine room (ER).

Table 5 describes condition parameters of the ship model on one damaged compartment where the leakage of the engine room (ER) as shown Fig. 5 and void tank No.1 (Void No.1) as shown Fig. 6. Those conditions impacted full water volume of 3689.3 mm³ and 2961.3 mm³ and took water ingress fully in 75 sec and 322 sec respectively. The draft of the ship model in the bow and stern parts caused by the water flooding was 2.75 cm and 6.14 cm on the leakage of the ER and 5.10 cm and 3.94 cm for the leakage of the Void No.1. For those conditions, the model experienced extreme stern trim (+) 0.034 rad on the leakage of the ER and extreme bow trim (-) 0.012 rad on the leakage of the Void No.1.

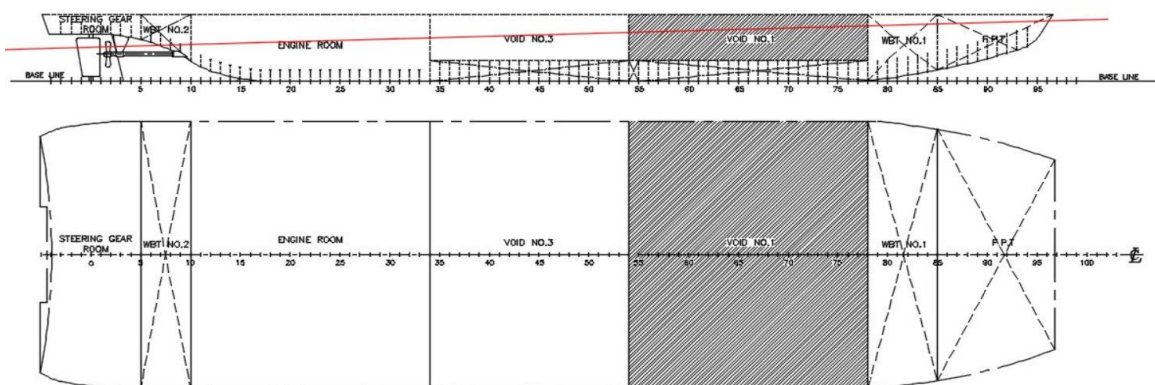
Figure 6. Damaged Void No.1.

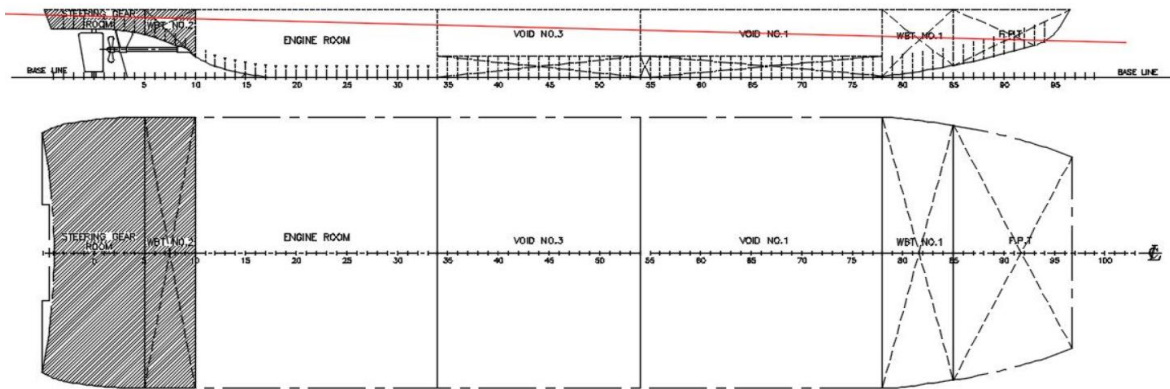
Figure 7. Damaged WBT No.2 and SGR.

For the parameters of the two damaged compartments scenario as shown in Table 6, the leakage of the water ballast tank No.2 (WBT No.2) and steering gear room (SGR) as shown in Fig. 7 simultaneously impacted full water volume of 896.464 mm³ in 84 sec. The water

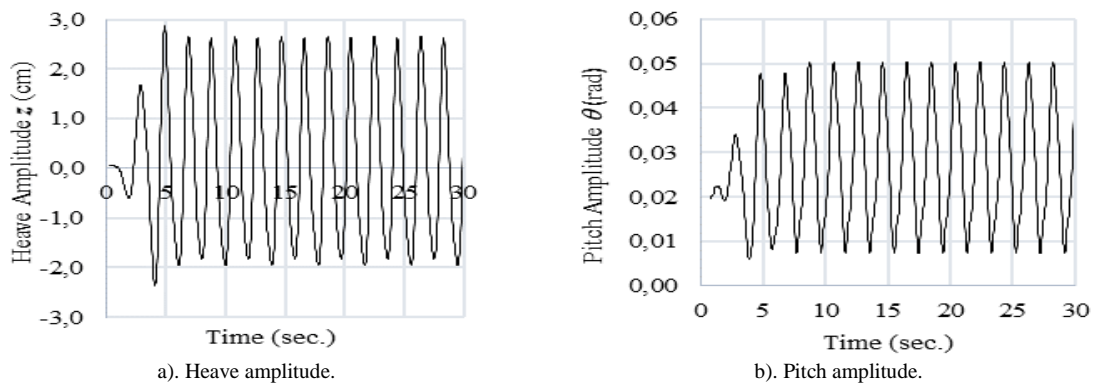
Figure 9. Time history of motion in heading wave within damaged ER.

Figures 9 to 11 show the examples of the time history of heave, pitch, and roll amplitudes for one and two damage scenarios. In the time history of motion, the heaving amplitude is indicated by (+) and (-) directions which mean a vertical up movement and a down movement respectively. The pitch amplitude indicated by (+) direction means a rotational movement to the stern of the ship model, and (-) direction means a rotational movement to the bow of the ship model. Then, the roll amplitude indicated by (+) direction means a rotational movement to the starboard side of the ship

Figure 9 shows the time histories of the heaving amplitude (a) and the pitch amplitude (b) within flooding water into ER in the heading wave. The initial center of gravity (CoG) point shifted vertically in a little magnitude to up (+) while flooding water into ER. After shifting the CoG point, the heaving amplitude of the vertical up movement (+) is higher than the vertical down movement (-). Similarly, the CoG point rotated to the stern model around 0.019 rad and then the rotational response tends to stern model (+) within flooding water into ER. The tendency of motion response is influenced by stern trim condition (+), and the wave load directed to the head bow of the model has impacted significantly the progressive water into ER as well as the slosh dynamic to the stern wall (bulkhead). In this scenario, the averaged amplitude of heave and pitch amplitude were obtained 2.17 cm and 0.03 rad respectively. In beam wave, the averaged amplitudes of heave and roll motions were obtained 4.69 cm and 0.09 rad respectively. In this case, the CoG point shifted a little magnitude to down (-) from the CoG point in intact condition. The amplitude in vertical up movement (+) is higher than in down movement (-), and then the rotational movement to the starboard side (+) has the same magnitude with port side (-). However, the CoG point tends transversely to the starboard side. This response is influenced by the sloshing impact, exciting moment, and wave direction to the port side.

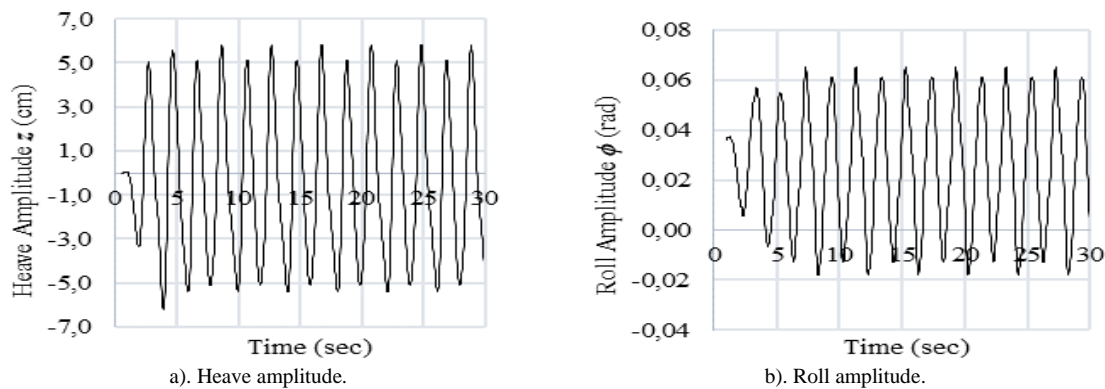
Figure 10. Time history of motion in beam wave within damaged Void No.1 and WBT No.1.

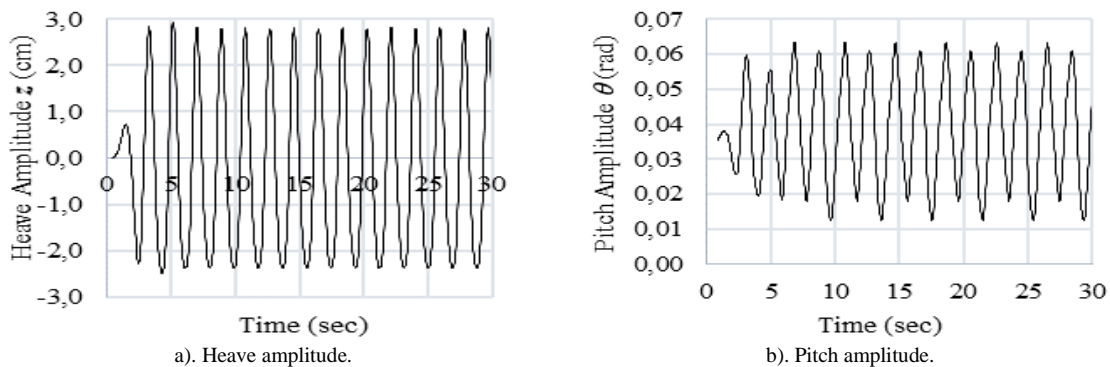
Figure 11. Time history of motion in heading wave within damaged SGR and WTB No.2.

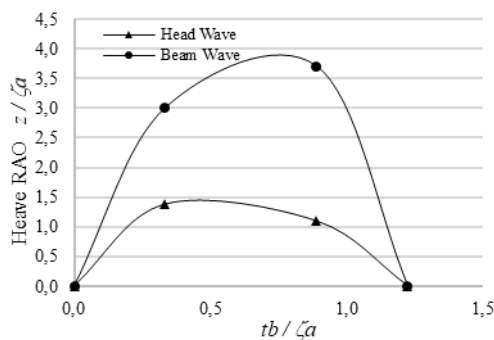
Figure 12. Heave RAO caused by increased bow trim in head and beam wave.

Figure 12 shows the nondimensional heave response of one damage condition of the damaged ER and the damaged Void No.1 respectively. The nondimensional heave response (heave RAO) is defined by the ratio between heave amplitude z and wave amplitude ζ_a or z/ζ_a .

For the effect of heading wave on heave motion, the increase of bow trim tb/ζ_a from 0 to 0.5 affects the increase of heave motion, and then heave motion tends to decrease until the water reaches the bow ship deck. In the same wave frequency, the heave motion tends to

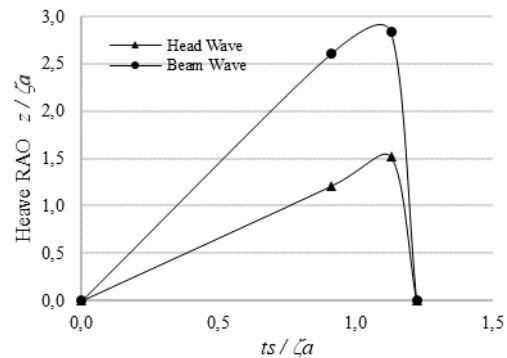
Figure 13. Heave RAO caused by increased stern trim in head and beam wave.

Figure 13 shows heave RAO caused by the increased stern trim ts/ζ_a . The tendency of both heave RAO in head and beam wave is similar where it tends to increase as linear as in increasing ts/ζ_a , and it decreases around 1.22. The heave response region is less than 1.0 when ts/ζ_a reaches around 0.73 in the heading wave and 0.4 in the beam wave. The response region of bow trim tb/ζ_a is larger than ts/ζ_a . This means the damaged compartment on the stern part of a ship could survive on exciting wave effect comparing with the damaged compartment in the bow part. However, this should be similar in a little damage.

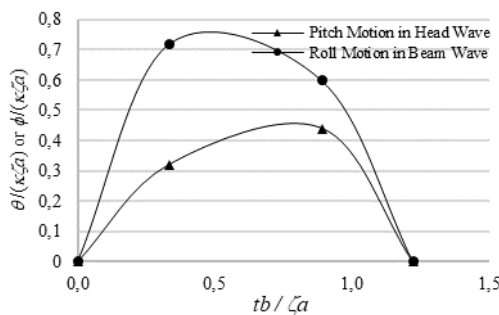
Figure 14. Pitch and Roll RAO caused by increased bow trim in head and beam wave.

Meanwhile, the nondimensional pitch or roll responses (pitch RAO or roll RAO) is defined by the ratio between pitch amplitude θ or roll amplitude ϕ and incident wave elevation that are $\theta/(k\zeta_a)$ or $\phi/(k\zeta_a)$ where k is wave number $2\pi/\lambda$. These RAOs are described in relation to the nondimensional parameter of increased trim (bow trim tb or stern trim ts) divided by encountering wave amplitude ζ_a that are defined by tb/ζ_a or ts/ζ_a . Figures 14 and 15 show pitch and roll RAOs caused by increased bow trim tb/ζ_a or stern trim ts/ζ_a in head and beam wave. The tendencies are similar to the tendencies of the heave RAO for bow trim and stern trim. The pitch and roll response seem small magnitude within the response region.

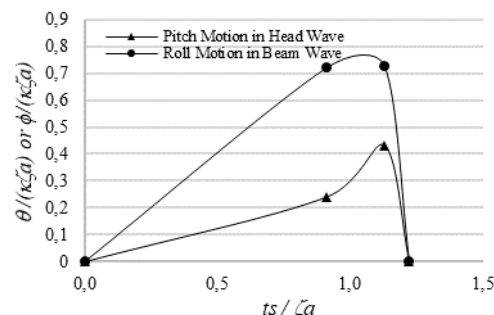
Figure 15. Pitch and Roll RAO caused by increased stern trim in head and beam wave.
