## Comparative Dimensional Accuracy of Dovetail and Airfoil EDM Defect on Gas Turbine Blades Using Camera Image and Micrometer

Gas turbine blades experience severe thermo-mechanical loading; therefore, dimensional examination of damage features must be accurate, repeatable, and non-destructive. This study develops and validates a non-contact digital image processing workflow to quantify artificial defects produced by die-sinking electrical discharge machining (EDM) on two blade regions with distinct surface characteristics: a serrated dovetail joint and a smooth airfoil. Six defects were manufactured (three per region) with nominal depths of 0.5, 1.0, and 2.0 mm. Repeatability was assessed using 20 measurements per defect (120 total) to determine accuracy via relative error and precision via standard deviation, followed by non-parametric and variance testing, and validation against a 0.001 mm resolution digital micrometer. Planar dimensions (length and width) achieved 97.5-99.9% accuracy, with overall accuracy above 95% and no significant difference in median accuracy between regions ( $P = 0.577$ ). Precision was significantly lower on the dovetail ( $P < 0.001$ ), attributed to

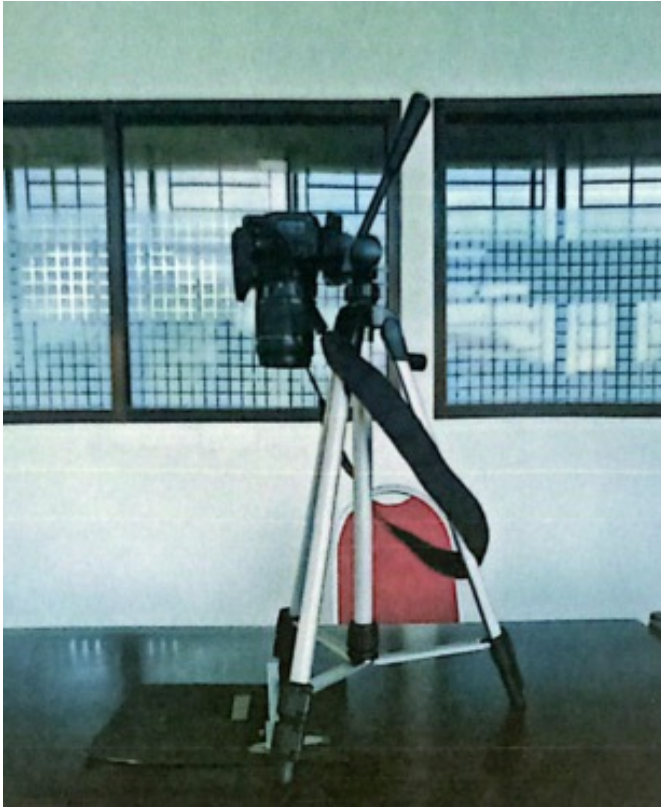
Figure 3. Camera setup.

The image acquisition process was conducted in a controlled environment to minimize noise. The camera was mounted on a tripod at a fixed distance of 30 cm from the specimen. Lighting intensity and camera settings ISO and shutter speed were optimized to ensure image clarity. Figure 3 shows the camera setup. To achieve high precision and accuracy, the camera system underwent meticulous calibration using a standard ruler of known dimensions. Initially, the ruler was positioned at the identical focal distance and orientation as the artificial defects on the turbine blade to eliminate any perspective distortion. To ensure optimal edge detection during this calibra-

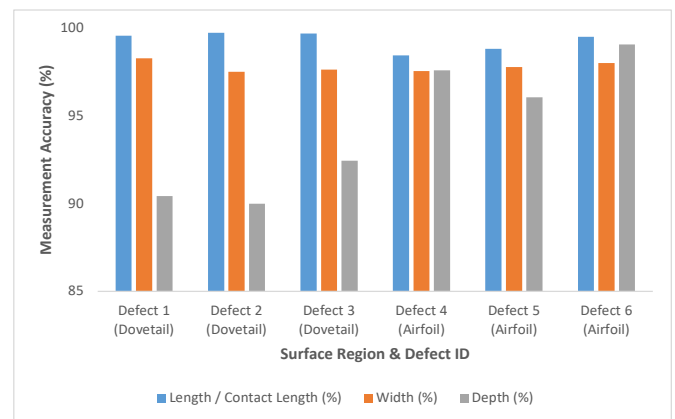
**Figure 6.** Comparison of measurement accuracy across all dimensions and defects.

Based on the data in Table 1 and Figure 6, distinct trends are observed regarding measurement performance. Dovetail defects exhibit very high accuracy in length measurements (e.g., Defect 1 at 99.85%). However, a significant decrease in accuracy is observed in depth measurements, where the dovetail region only achieves approximately 90% accuracy (e.g., Defect 2 at 89.99%). This decrease in depth accuracy is scientifically attributed to the complex, jagged geometry of the dovetail root. The jagged geometry creates numerous shadows and structural edges that compete with the artificial defect boundaries. These shadows interfere with the image segmentation process, making it difficult for the algorithm to distinguish the true defect depth from geometric noise.

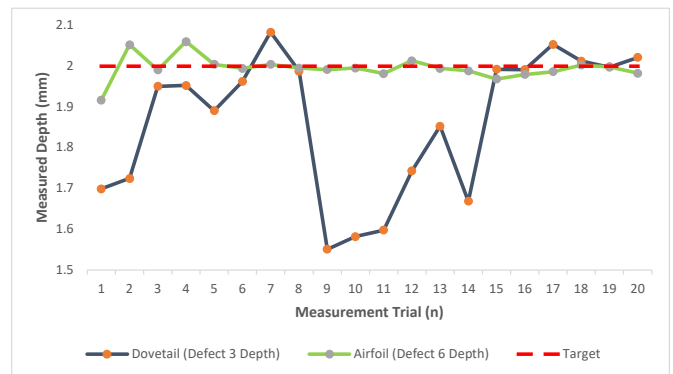
**Figure 7.** Repeatability analysis comparing 20 successive depth measurements on dovetail and airfoil surfaces at defect 3 depth and defect 6 depth.

To thoroughly examine how surface geometry influences measurement accuracy, a statistical analysis was conducted using Minitab software. This analysis utilized the complete raw data set consisting of 20 repeated measurements for each of the six artificial defects, resulting in a total sample size of  $n = 120$  data points. This substantial sample size ensured strong statistical power for hypothesis testing. Initial data verification using the Anderson-Darling test indicated that the error distribution for the dovetail region was non-normal with  $P$  value  $< 0.05$ . Consequently, non-parametric test was used for comparative. Here Figure 7 below shows repeatability analysis comparing 20 successive depth measurements on dovetail and airfoil surfaces at defect 3 depth and defect 6 depth.

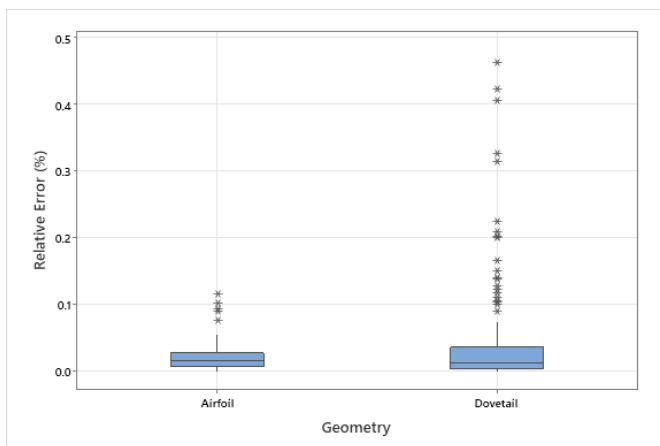
**Figure 8.** Boxplot comparison of measurement errors between dovetail and airfoil surfaces.

As illustrated in the boxplot in Figure 8, the interquartile range for the dovetail region is significantly wider than that for the airfoil region. This phenomenon is attributed to the complex surface topology of the dovetail region. Unlike a simple flat surface, this region has a jagged profile with a curvature. This geometric condition creates non-uniform lighting and shadow zones that compete with the edges of artificial defects during the segmentation process. As a result, the algorithm struggles to isolate defect boundaries consistently. In contrast, the airfoil surface exhibits a smooth and continuous curvature without abrupt ridge transitions. This surface characteristic allows for a uniform lighting gradient against the background, thus enabling the thresholding algorithm to detect the defect edges with greater stability and precision.
