Seismic Risk Analysis for Critical Infrastructure: The Case Study of a Medical Center and its Supporting Systems in Yangon, Myanmar

Abstract— Myanmar has a great strike-slip active fault called the “Sagaing Fault Zone” besides the Sumatra-Andaman Subduction Zone. Major cities (Yangon, Naypyitaw, Bago and Mandalay) are at risk along this fault. Recently, in 2012, Thabeikkyin earthquake with Magnitude of 6.8 caused collapse of many residential housings and ground failures near Mandalay. Therefore more attention should be paid for Yangon which has no large earthquakes since 1930 and is the largest not only in population but also in socio-economic activity. One of the most important concerns after an earthquake is to survive under any disastrous conditions. The medical care is requested not only for emergent injured people after an earthquake, but also for various types of patient and aged people from several weeks to longer periods. So medical center must be always functional before and after earthquake. For this purpose, medical buildings should be structurally resilient and also be functional for medical services by sustainable supply of electric power, water and any other delivery

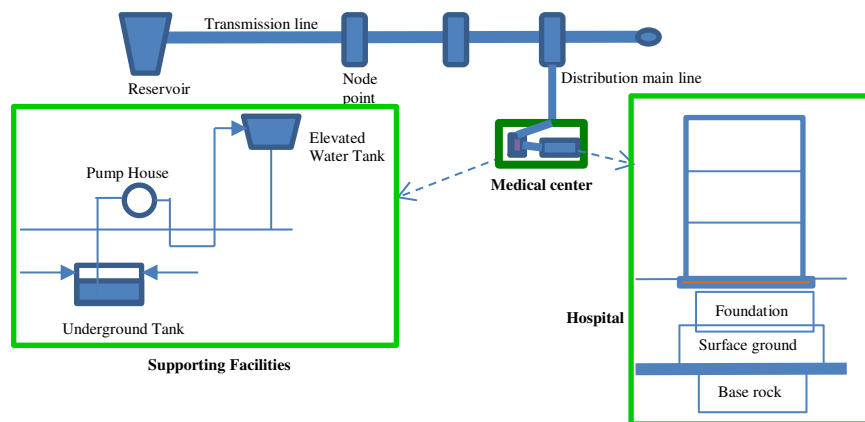
Figure 2. Schematic illustration of selected area of the study

This research is to investigate the structural vulnerability of hospital buildings and facilities, to assess the performance of urban lifeline systems and to check the operational capability of medical services. Schematic illustration of study area is shown in **Figure 2**.

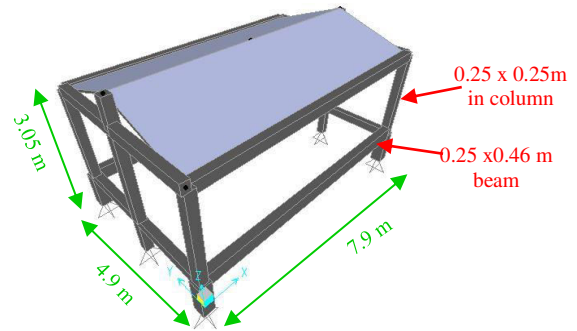
Existing structure

3D modeling of pump house

Figure 8. Modeling of pump house

The supporting buildings for water supply system include underground water tank, pump house, elevated water tank and ground tank. The configurations of these structures are different in terms of height, existing conditions, locations, function, and their seismic resiliency. Pump house, elevated water tank and ground tank are above-ground structures whereas underground tank is under-ground structure. All the supporting structures are assumed to be reinforced concrete structures. Modeling of these structures are shown in **Figure 7 to 11**.

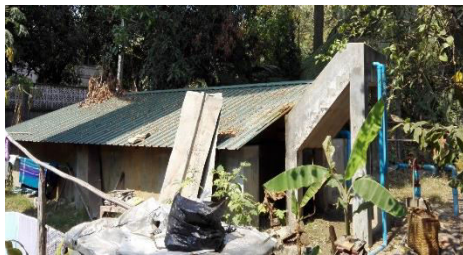
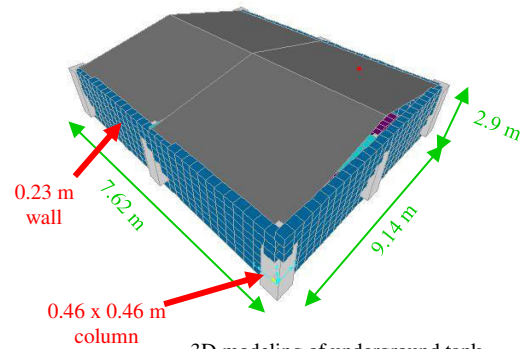
Existing structure

3D modeling of underground tank

Figure 10. Modeling of underground water tank 2

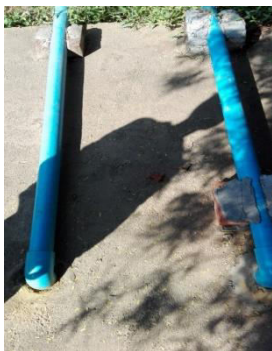
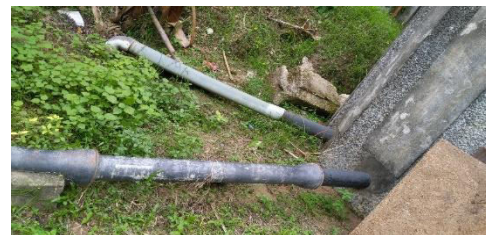
Figure 11. Existing Conditions of Some Pipe Segments and Pipe Joints

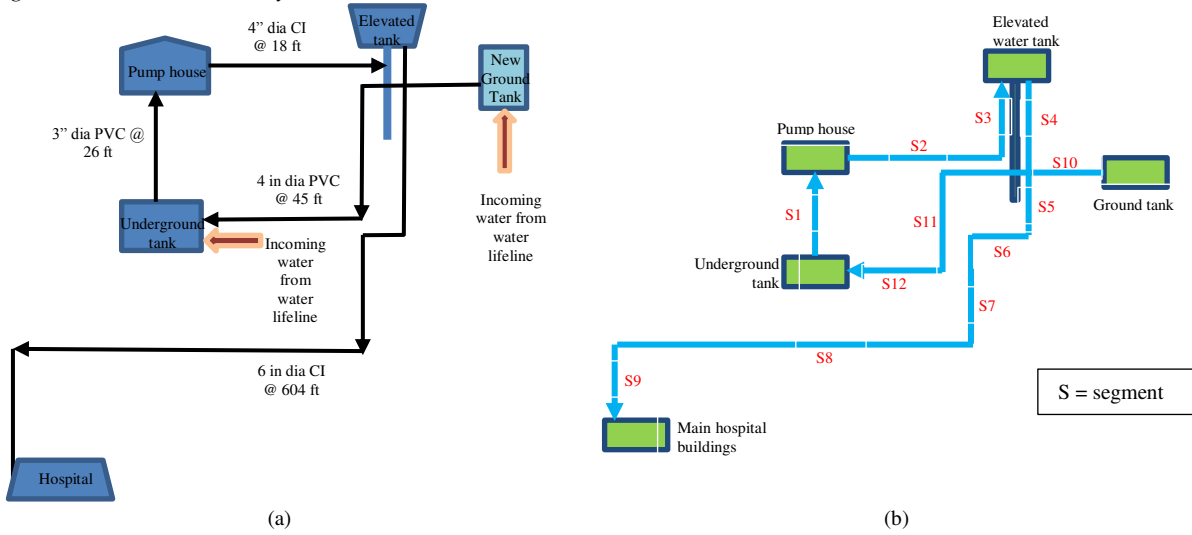
Figure 12. (a) Plan configuration of water supply system in the hospital; (b) Modelling of water supply system in the hospital

All the connection types between the two segments are mechanical joint and the failure mode of this type of joint is due to excessive joint axial displacement. Therefore, in this study, the safety assessment of water pipelines is carried out in terms of joint axial displacement. The existing conditions of pipelines and joints are shown in **Figure 12 (a)**.

For knowing the probability of failure of each pipe, the fragility curves of each pipe segment (shown in **Figure 12(b)** and **Figure 13(b)**) are developed as a function of spectral acceleration. The fragility curves are developed using the displacements obtained from pushover analysis and joint axial displacement calculation for various spectral accelerations.

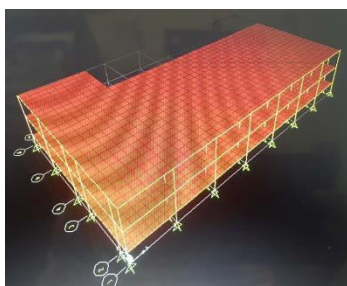
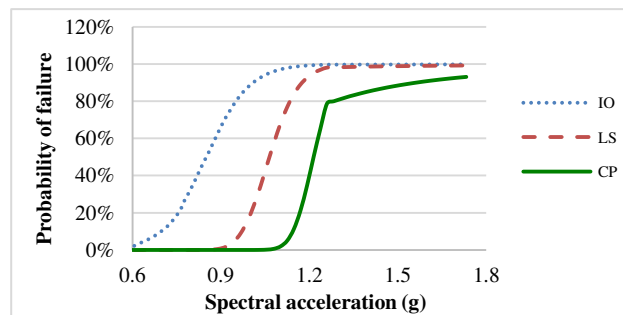
Figure 14. (a) Section 1 of main hospital building; (b) Fragility curves of section 1 for MOE, DBE and MCE levels

where, P_f is probability of failure; Z is demand – capacity; EQ is earthquakes; u_{cr}^{EQ} is critical displacement for a certain limit state; u_{max}^{EQ} is maximum displacement due to a certain earthquake; σ is standard deviation; μ is mean value and Φ is standard normal distribution. The fragility curves of hospital building and its supporting structures are shown in **Figure 14 to 21**.

Structures	Earthquake Levels	Target Performance Levels		P_f (%)
		Performances	Damage States	
Main Building: Section 1	MOE	IO	Minor wall cracks <1/16in	21.03
Main Building: Section 2	DBE	LS	Crushing & flexural cracking	0.83
	MCE	CP	Serve boundary element damage	91.77
	MOE	IO	Minor wall cracks <1/16in	55.6
Main Building: Section 3	DBE	LS	Crushing & flexural cracking	26.36
	MCE	CP	Serve boundary element damage	92.4
	MOE	IO	Minor wall cracks <1/16in	77.24
Main Building: Section 4	DBE	LS	Crushing & flexural cracking	96.97
	MCE	CP	Serve boundary element damage	99.36
	MOE	IO	Minor wall cracks <1/16in	35.77
Under-ground water tank	DBE	LS	Crushing & flexural cracking	95.65
	MCE	CP	Serve boundary element damage	97.07
	MOE	IO	Minor wall cracks <1/16in	0.17
Pump House	DBE	LS	Crushing & flexural cracking	0.09
	MCE	CP	Serve boundary element damage	0.07
	MOE	IO	Hairline cracks & limited yielding	93.6
Elevated water tank	DBE	LS	Beam damage, column shear cracks	73.8

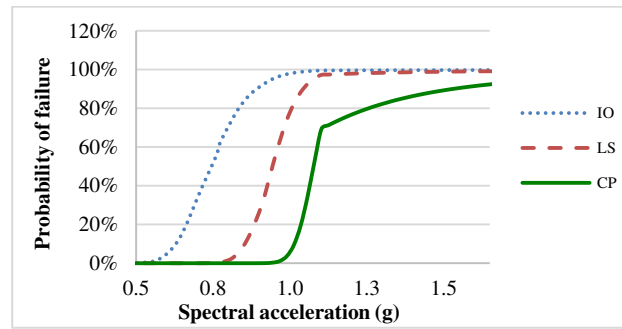
Figure 15. (a) Section 2 of main hospital building; (b) Fragility curves of section 2 for MOE, DBE and MCE levels
