# Implementations of Autonomous Maintenance to Relieve Stoppages on PT NIKF – Sachet Packaging Chain

**Abstract**—Autonomous maintenance taught operator to keep devices, create cooperation each employer and did problem solving that occurring in machine. This research described assembling of autonomous maintenance on PT NIKF – minor stoppages trouble in sachet production line. Our team used the OEE method to know the latest line condition and variety losses that causing the performance were not optimal. After that, the next steps were using visual losses map and diagram Pareto to get the detail (component with many losses). By Go See Think Do, the researcher could find much maintenance that must be done in SIC line 1. Through the application, this effort could reduce the losses of minor stoppages - 79,52%.

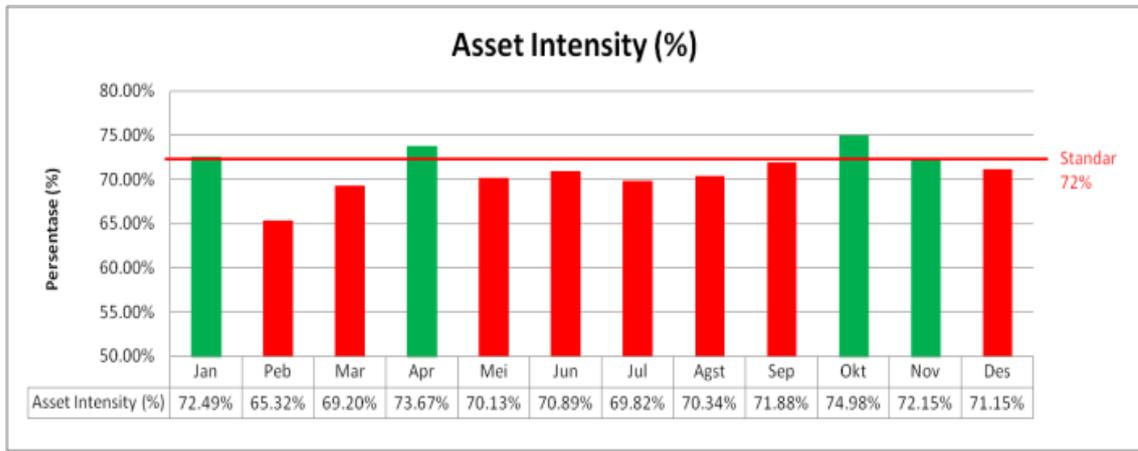
Figure 1. Achievement of asset intensity in SIC line 1 (source by annual report of PT NIKF).

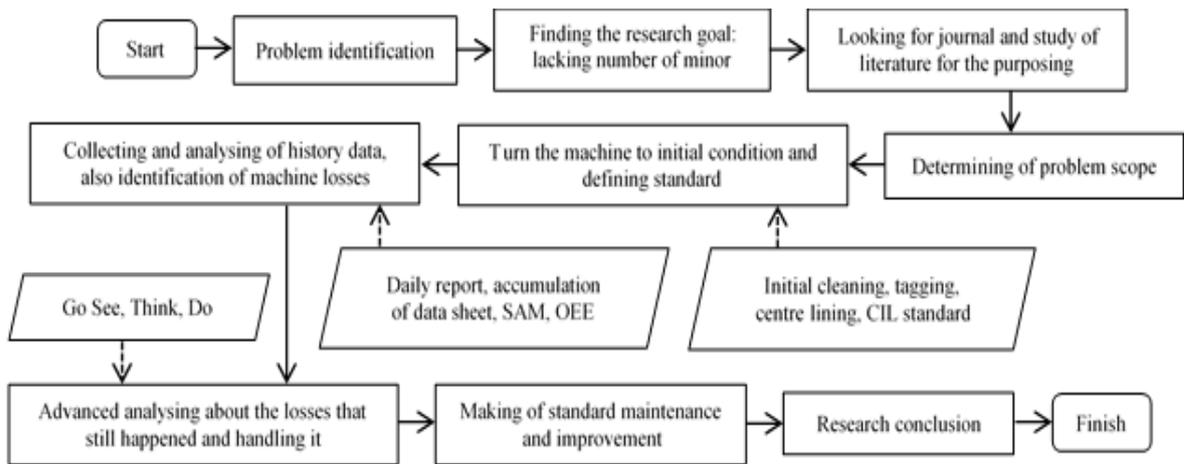
Figure 2. Flowchart of research method.

Methodology that used this research was resumed in Figure 2.

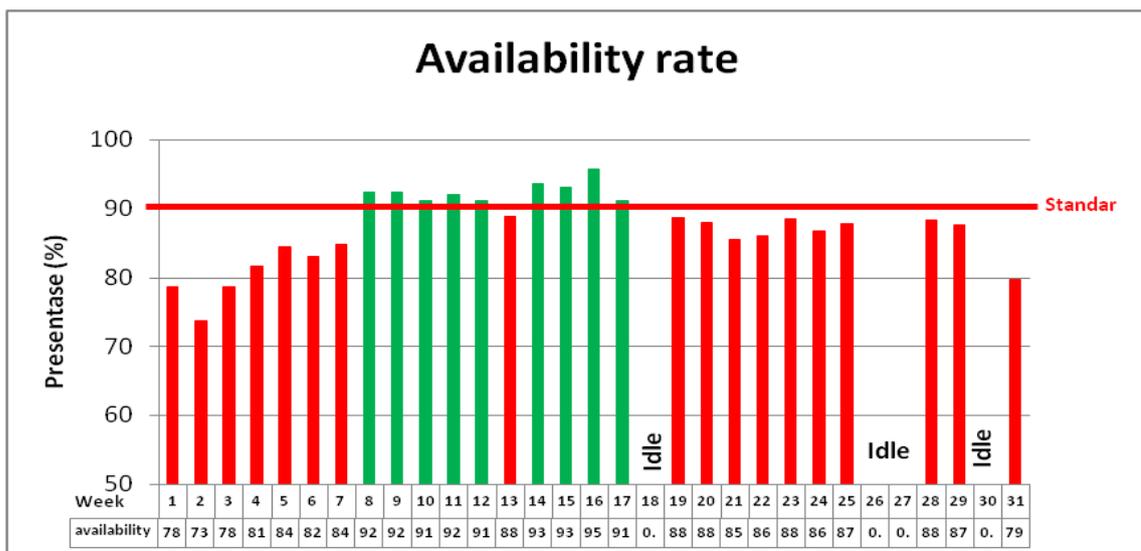
Figure 3. Trend of availability ratio point

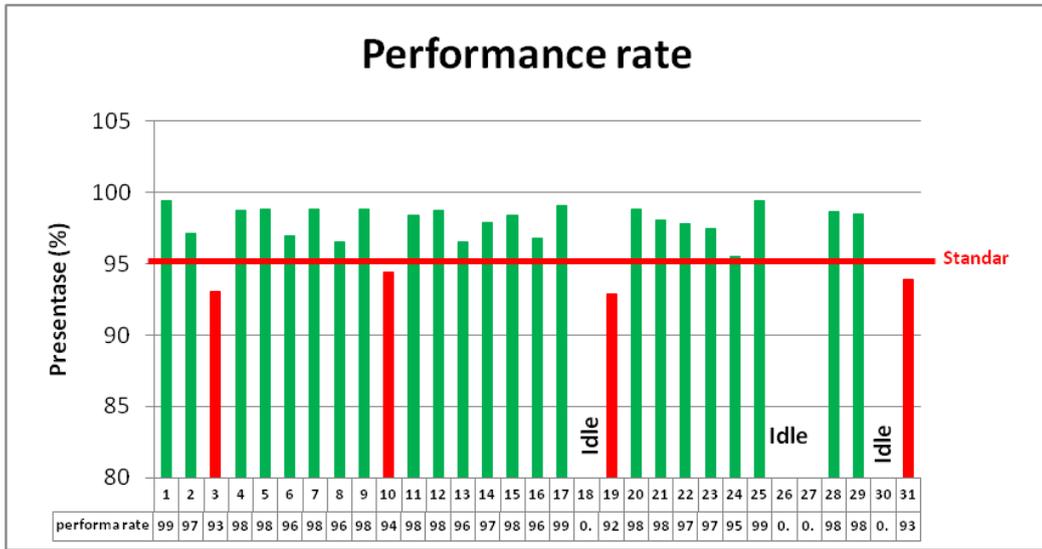
Figure 4. Preference of performance rate.

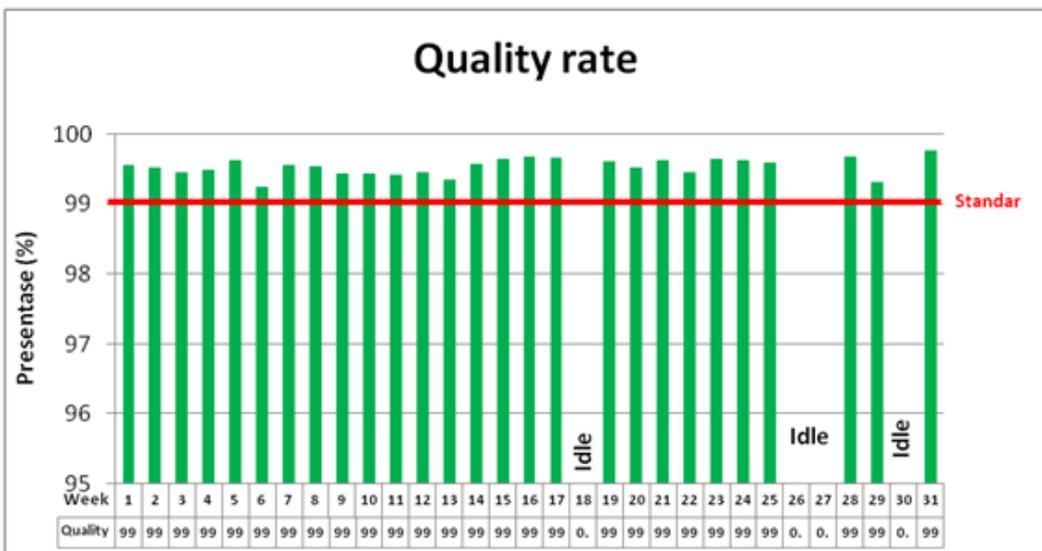
Figure 5. Inclination of quality ratio.

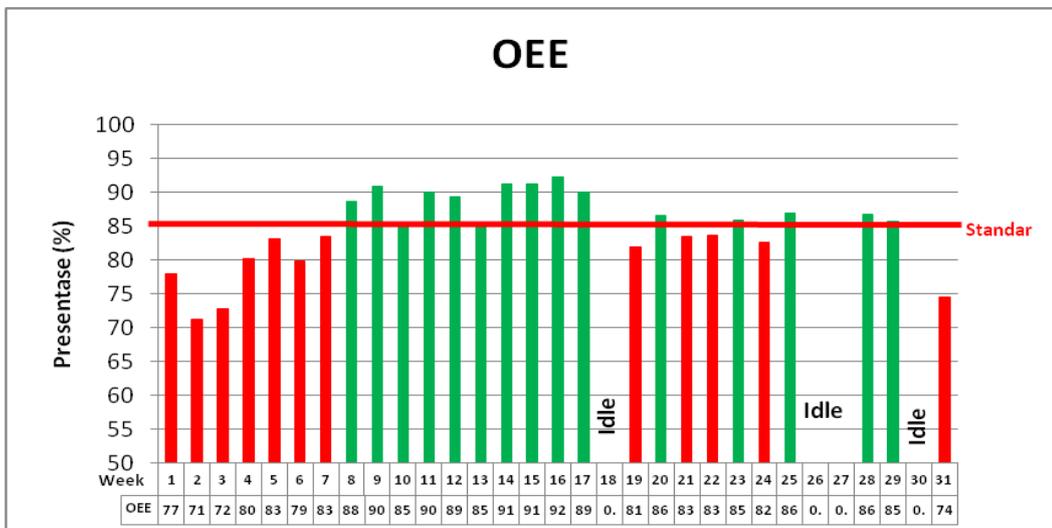
Figure 6. Trend of OEE score.

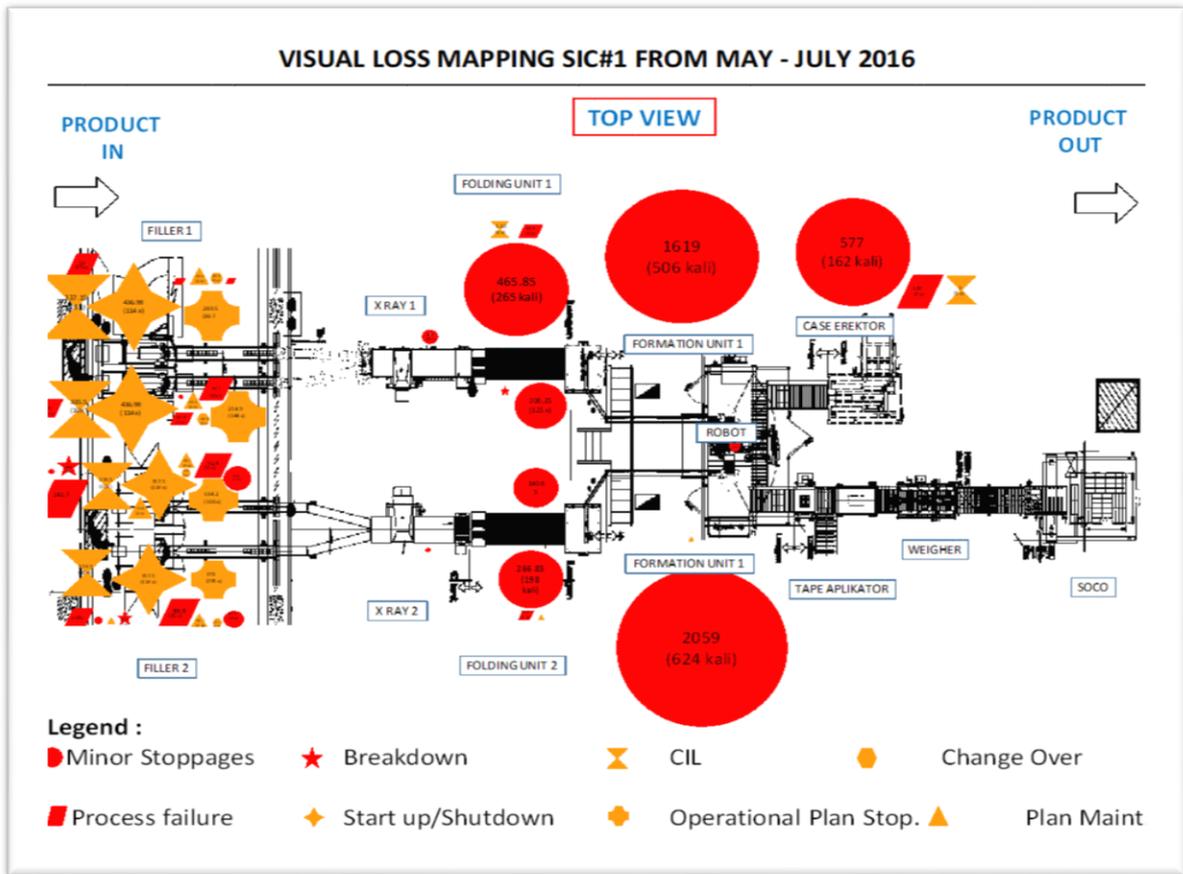
The researchers used Visual Loss Mapp to guide where and how long stoppages. Data that needed was stoppages data from SAM software for 3 months (May – July, 17th to 31st week, see Figure 7 below). The image explained

that the biggest problem was minor stoppages in packing area such as sachet jammed in 2nd formation unit (2059 minutes, 624 times) and 1st was 1619 minutes, 506 times. Next, in 1st and 2nd folding unit were 465,85 -- 265 and 266,85 minutes --198 times consecutively.

Figure 7. Outlet visual loss map in SIC line 1 in May – July (Source: stoppages analysis modulus – SAM in SIC line 1).

Based on Figure 7, the researcher pulled the data in 31st week to know the newest condition in SIC line 1. Pareto diagram was given in Figure 8 to review and understand minor stoppages in last time.

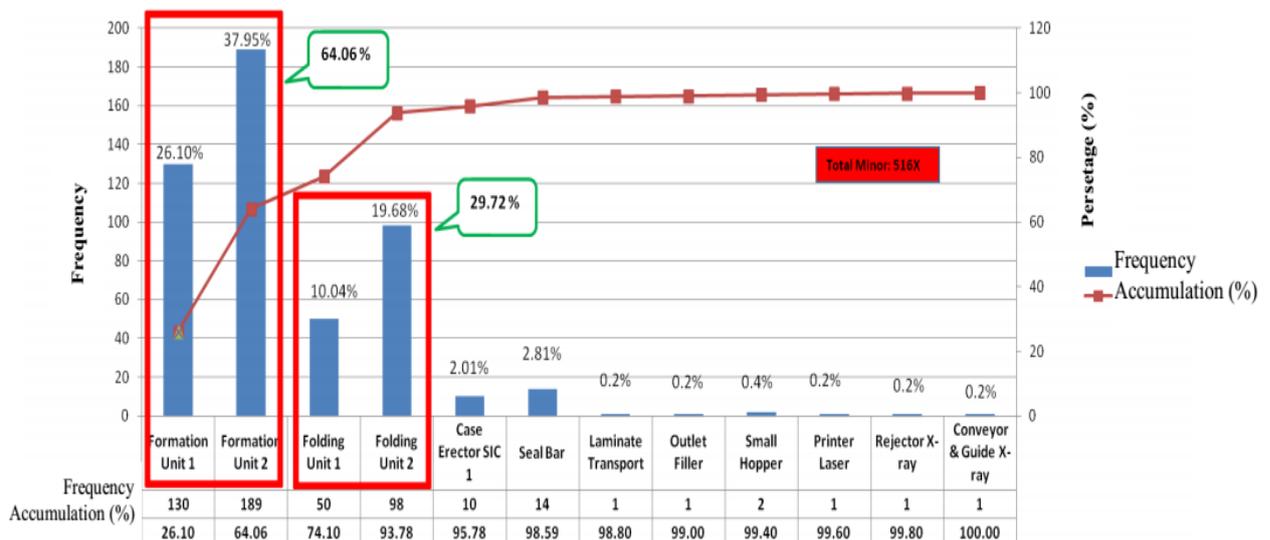
Figure 8 showed that two machine component that donating higher minor stoppages was 1st and 2nd formation unit, 64% and 29,72% in Folding 1&2 Unit. So high condition (almost 93,78%) could be certain that the both tools got improvement. Analysing to the component utilized Go See Think Do (GSTD) way to find out the question source and then fixing treatment.

Figure 8. Pareto diagram of minor stoppages in SIC line 1 – 31st week.

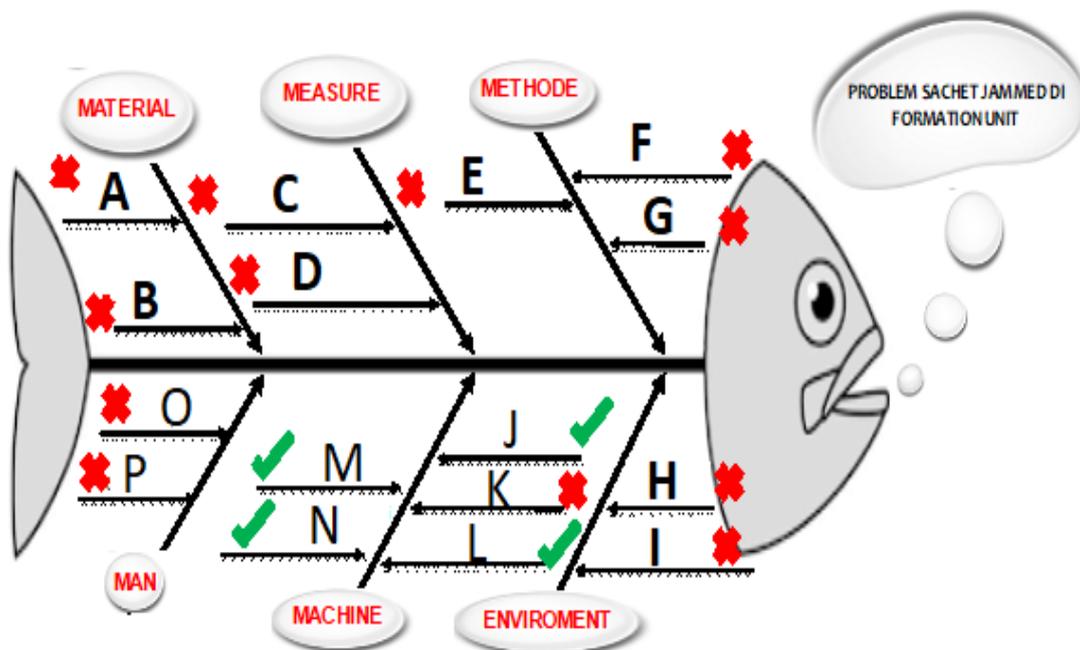
After founded the existed problem and standard investigation still happened so next ways was looking for the cause by thinking point. It was done through group – brainstorming to get possible cause. In this stage, the researcher used device – fishbone and 5WHY analysis (Figure 9 and Table 2). Figure 9 showed that the matters were J, L, M, and N.

A = case did not open, B = soon vacuum in robot was hard, C = parameter of stopper plate had changed, D = puffing device was not calibrated, E = conveyor installation of formation unit was wrong, F = how to pair

magazine case was wrong, G = standard cleaning was not exist yet, H = area of formation unit was slippery, I = area of formation unit was dirty, J = sensor did not detect sachet, K = loss vacuum in robot, L = tip of the sachet stuck in finger pusher, M = end of the sachet stuck in sensor hole, N = sachet left in separation unit, O = new operator, P = skill operator.

Figure 9. Fishbone of sachet jammed in formation unit through Think step.

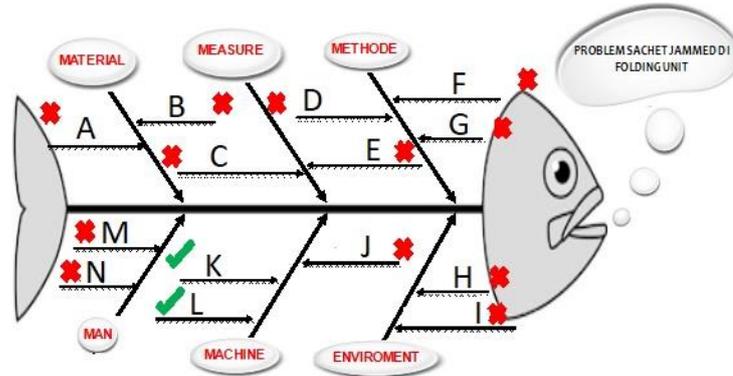
Figure 10 showed that two point of possible of root cause were K and L. Then, the problems were analyzed

Figure 10. Fishbone of sachet jammed in folding unit through Think step.

A = laminate was rigid and shiny, B = sachet puffing was not standard, C = puffing device was not calibrated, D = installation of conveyor folding was wrong, E = parameter of folding unit had changed, F = puff checking had difference, G = cleaning standard was not existed

yet, H = are of folding unit was slippery, I = area of folding unit was dirty, J = the sensor did not detect sachet, K = sachet stuck in drop plate, L = failure in folding process, M = new operator, N = skill operator.

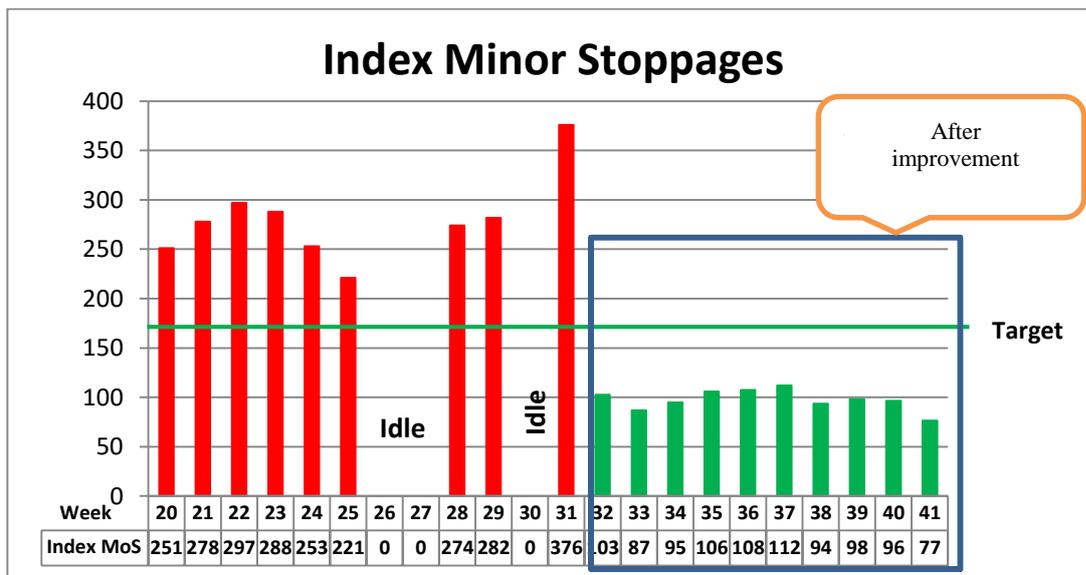
Figure 11 showed that significantly decreasing for index minor stoppages in SIC line 1. After improvement, score could reach lower capability, 77 index minor stoppages in 41th weeks. Based on 31st data, the

problem leaked with 79,52%. It had indicated that the improvement from GSTD in Formation and Folding 1&2 Unit 2 was completed.

Figure 11. Index minor stoppages in SIC line 1 before and after improvement.

In Formation and Folding 1 & 2 Unit, the stakeholder had discussed the root causes and they were doing improvement. All progress was monitored to know success or not the action. If it was good perform so new standard was got and the company would do training and introduction to operator [7]. The action also was done in food industry as continuous improvement process [8]. This way aimed keeping result. In another hand, this chance did not work so other problems solving that more detailed used DMAIC (define, measure, analyse, improve, control) method. The evaluation was access every 10 weeks (from 32nd – 41st weeks) and it was served in Figure 11.
